## Saint Peter's Episcopal Church Report

June 30, 2008

## Report Summary

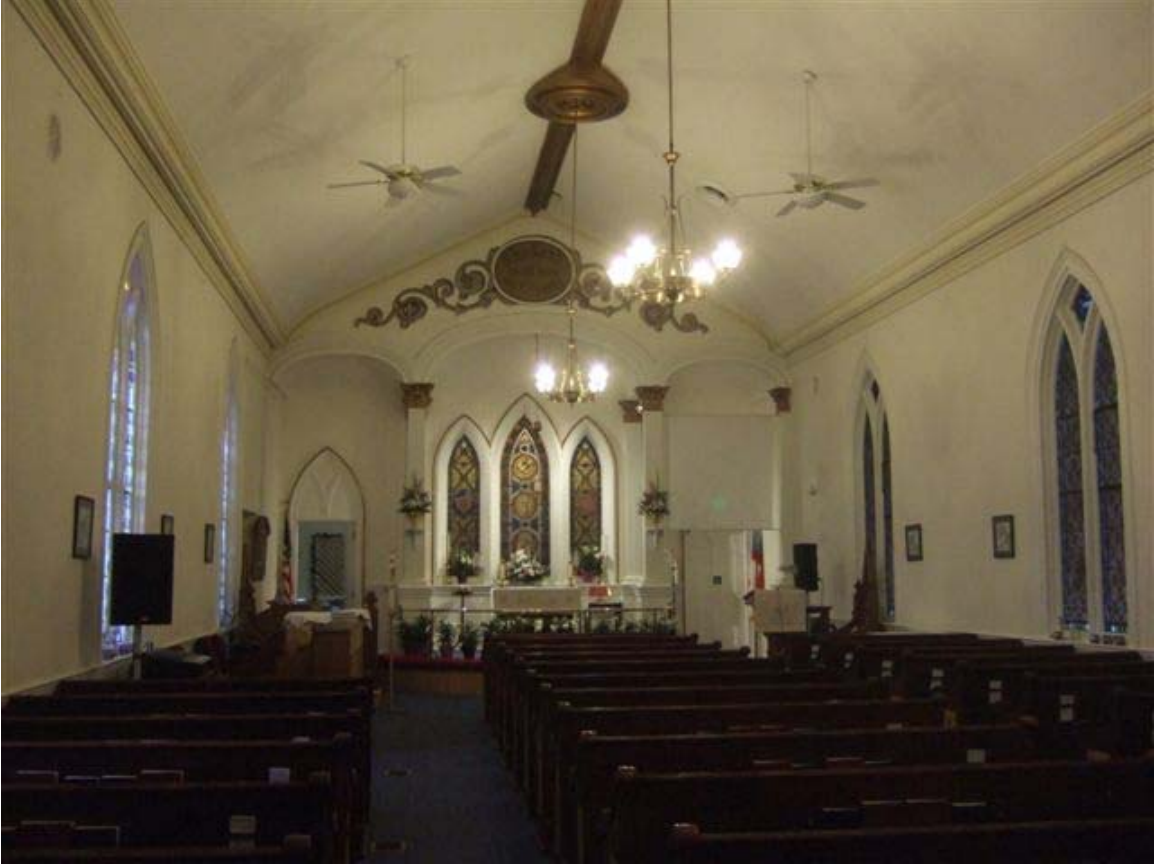
2. The nave, looking toward the chancel.

nave was recarpeted with red carpeting.) The nave is a rectangular space focused on the chancel at the west end. The ceiling has a peaked or Tudor-arch section with heavy plaster moldings where the two planes meet the walls and a heavy molded plaster spine along the peak. At two points along the spine are heavy molded medallions with bas-relief pears, acanthus leaves, and buttons at their center points from which chandeliers hang. At points along the side walls under the plaster cornice are ornate circular registers for a ventilation system added in 1873-74.

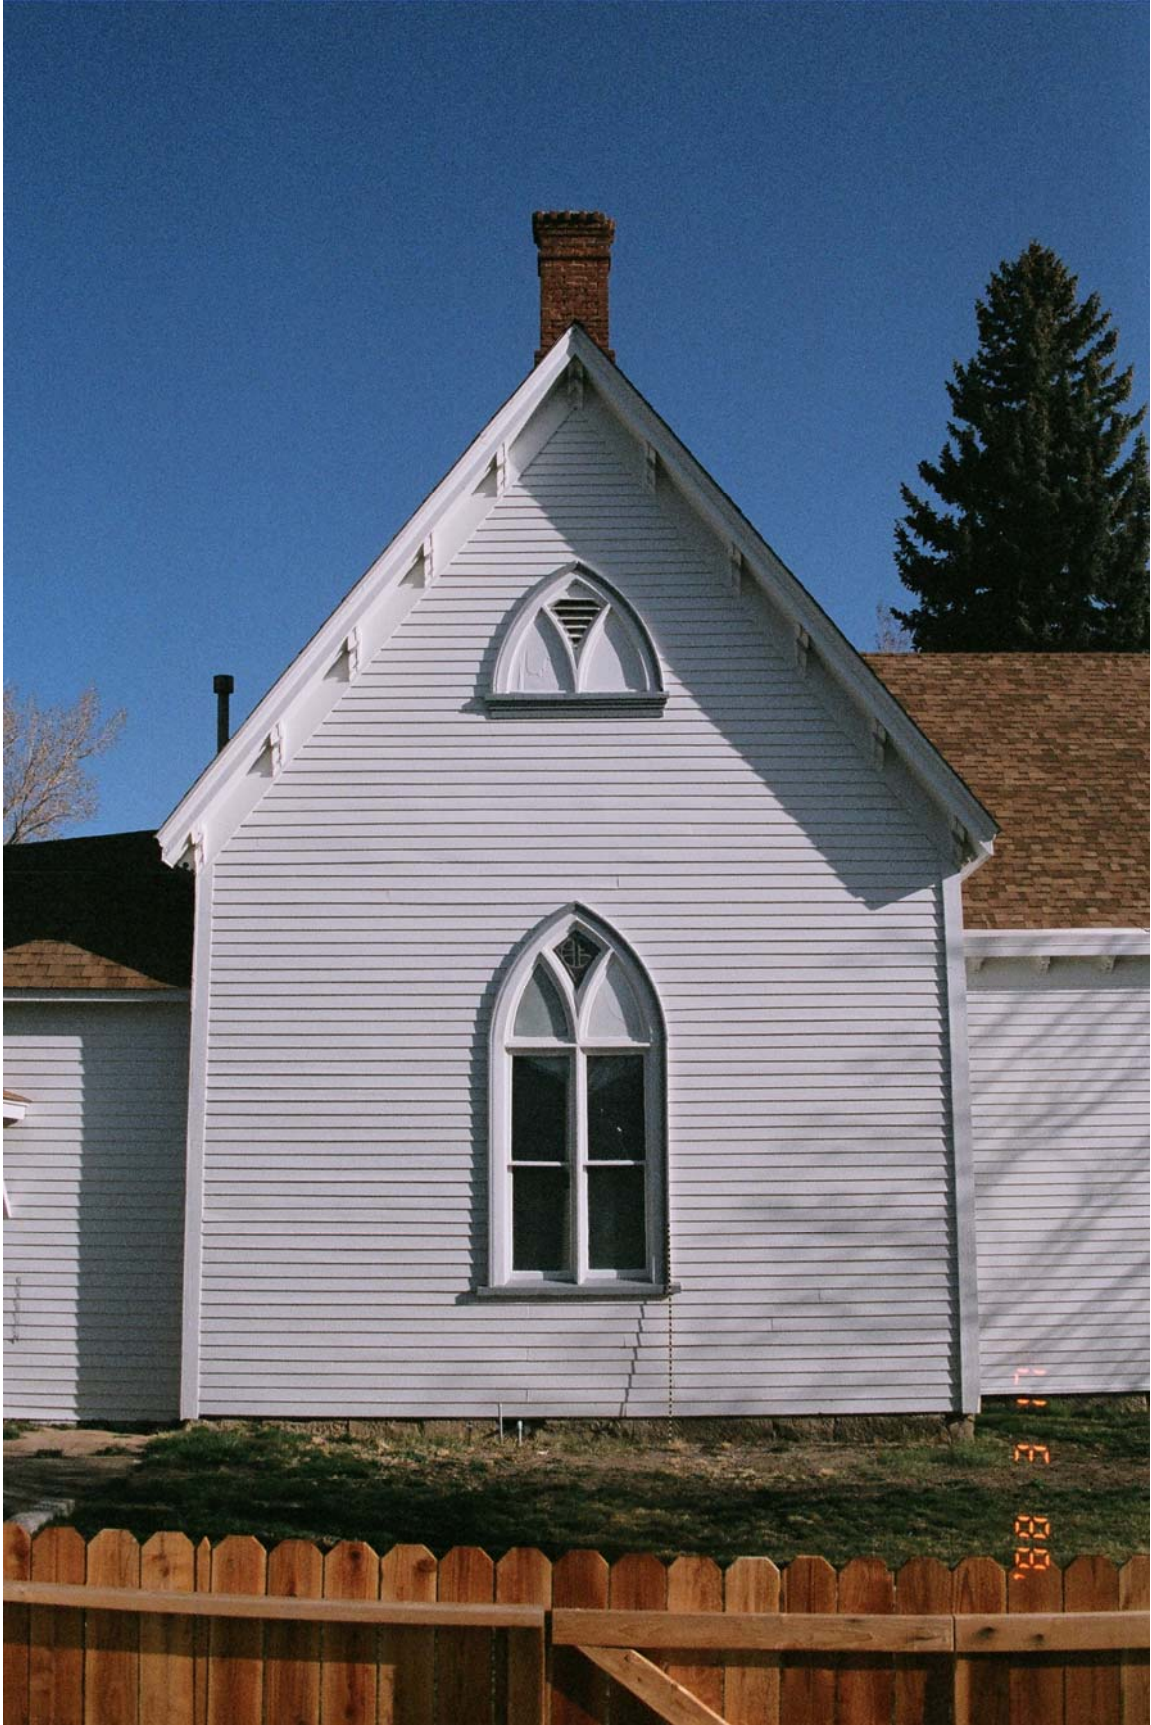
4. The south end of the 1873-74 addition is visible in this view.

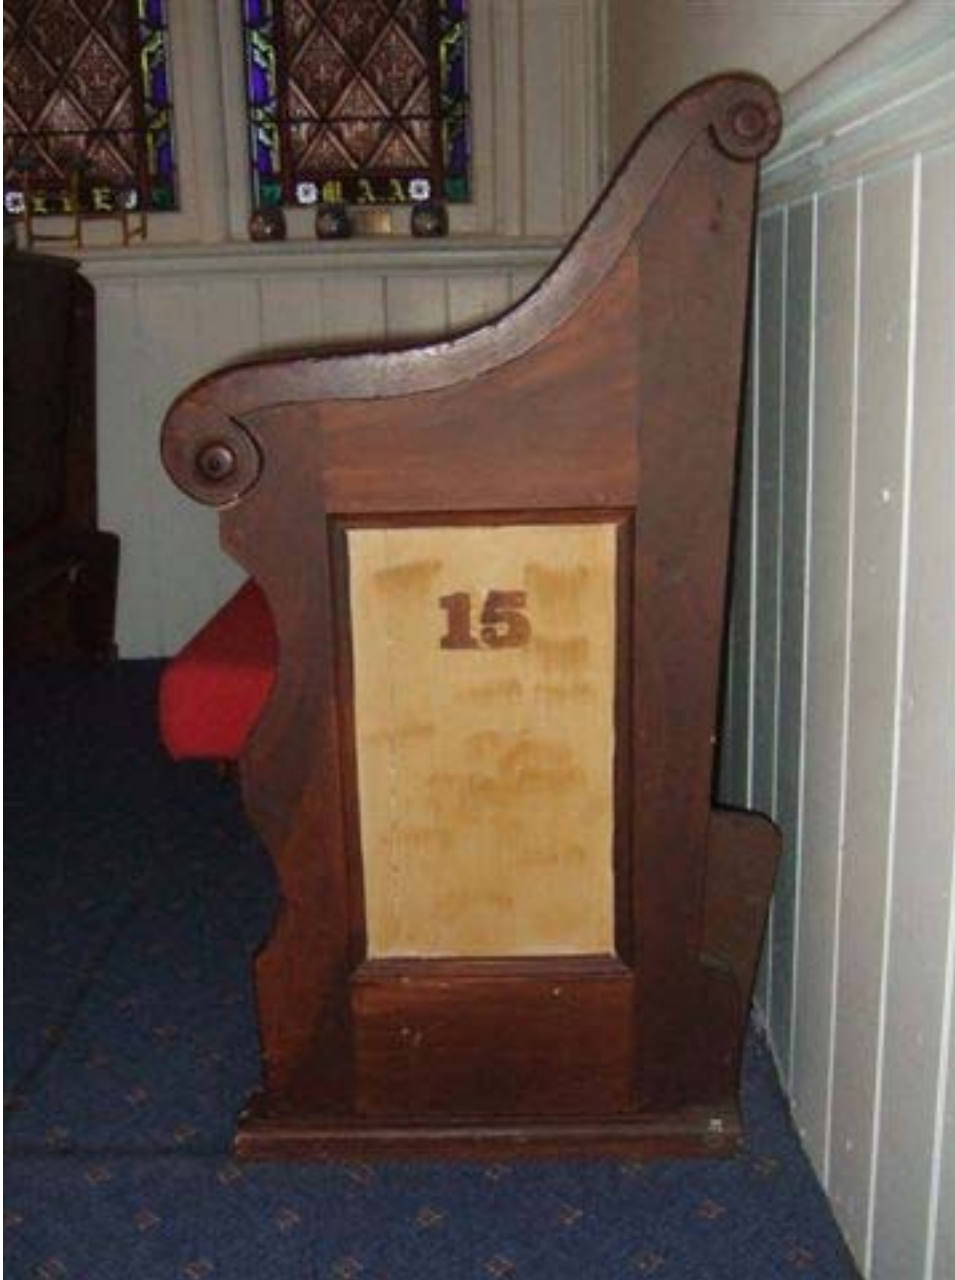
5. A pew with koa wood graining.

French gray, the wall color described in the *Appeal* account, in modern formulations has a rich, almost pewter tone. The color has not been observed exposed in St. Peter’s interior, but it may have been similar to one of the shades of light gray discovered in the furnace enclosure in the St. Peter’s Rectory. The Rectory was not owned by the church at the time, but nevertheless its early paint colors may have been representative of colors used elsewhere in Carson City during the 1870s. Another color treatment mentioned in the 1874 accounts is the Sandwich Island mahogany graining of the pews. The Sandwich Islands are the Hawaiian Islands, and the wood referred to is koa, which is today prized for furniture and specialty surf boards. Koa is a fine-grained wood with variegated colors that range from blond to deep brown. These are the colors used for St. Peter’s pews, and

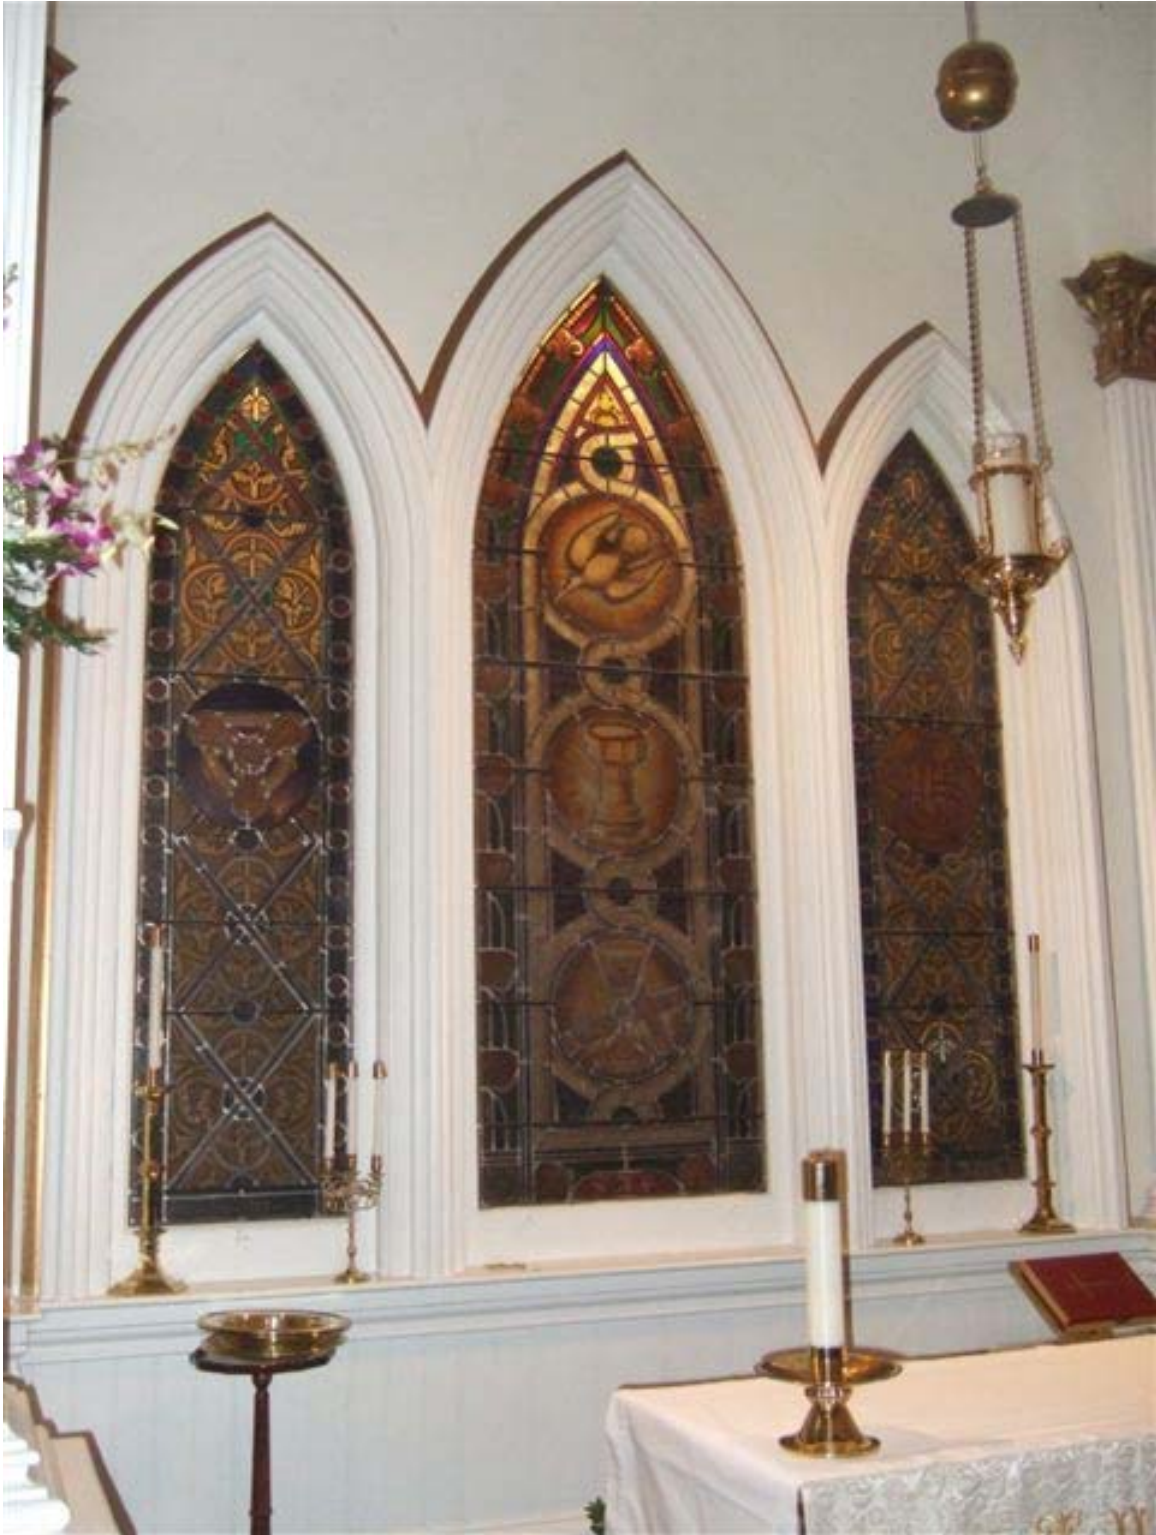
6. Chancel window.

“The Chancel Window, on the school room side, presents a fine display of cluster bead work, tastefully designed and admirably finished. The window is in three sections, which are weighted from above, and can be pushed up out of the way with a touch whenever it

At the back of the chancel is a triplet lancet window containing stained glass and framed with white and gilt painted moldings. The taller center window has a green, red, gold, and blue border with yellow fleurs-de-lis (that appear to grow out of the green border) and three roundels containing (from top to bottom) a dove, font, and chalice. At the bottom is a panel with the initials S.J.F. The flanking windows have blue borders with red rosettes and, inside the borders, red lattice and yellow quatrefoil patterns on white glass painted with foliation and crosshatching. The left window has a blue roundel with a symbol of the

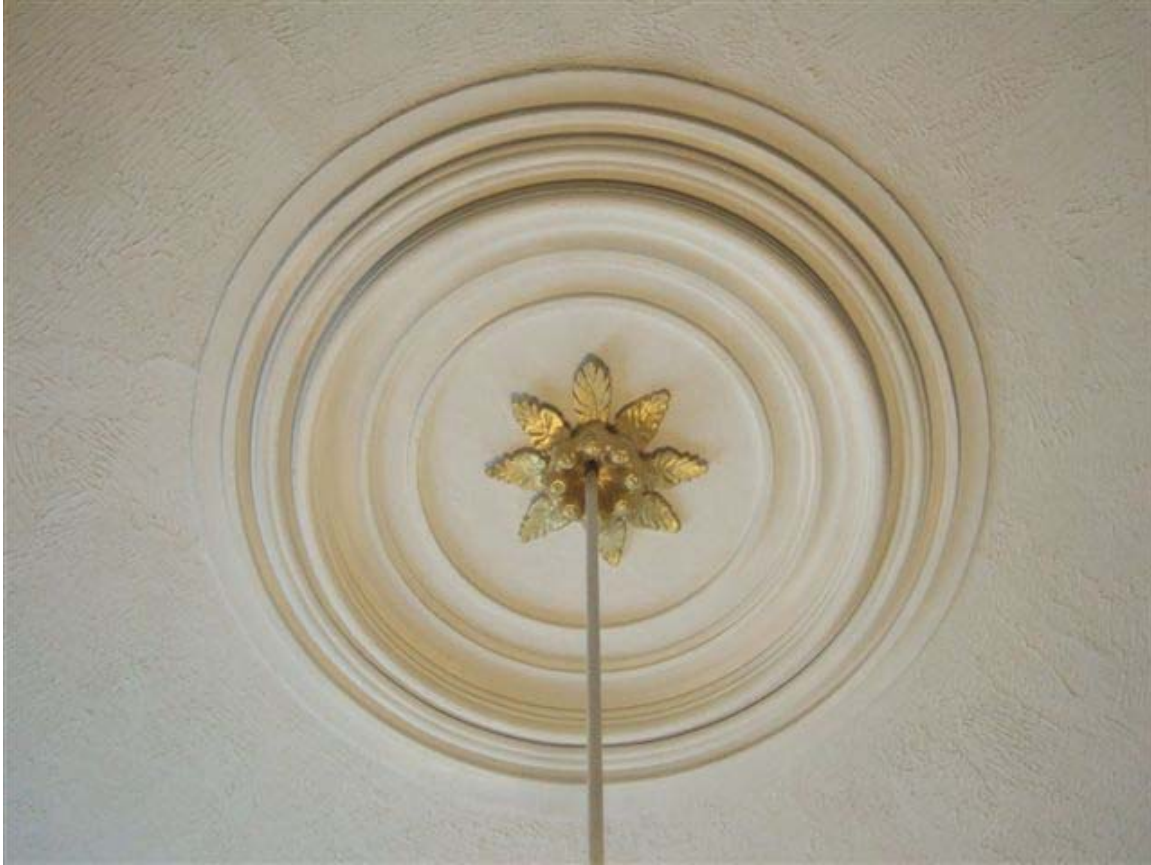
7. Parish hall ceiling medallion.

may be necessary for the sake of better ventilation, or in order to bring the congregations in school-room and church into one audience. The ceiling of the school apartment is decorated in a lovely manner with three centre pieces for chandeliers; the middle piece made of large moulding with a beautiful white core on a ground of blue; the side pieces of smaller moulding, with similar core, on orange-colored ground.

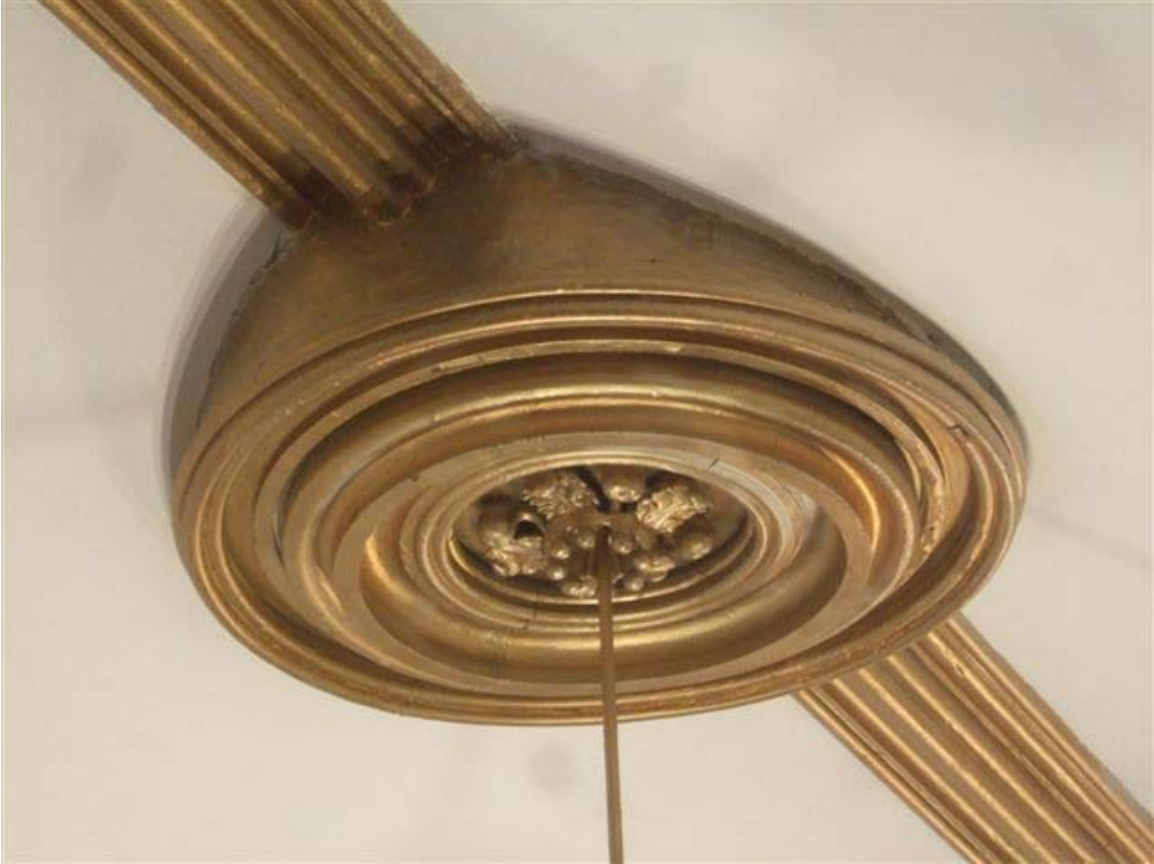
8. Nave ceiling medallion.

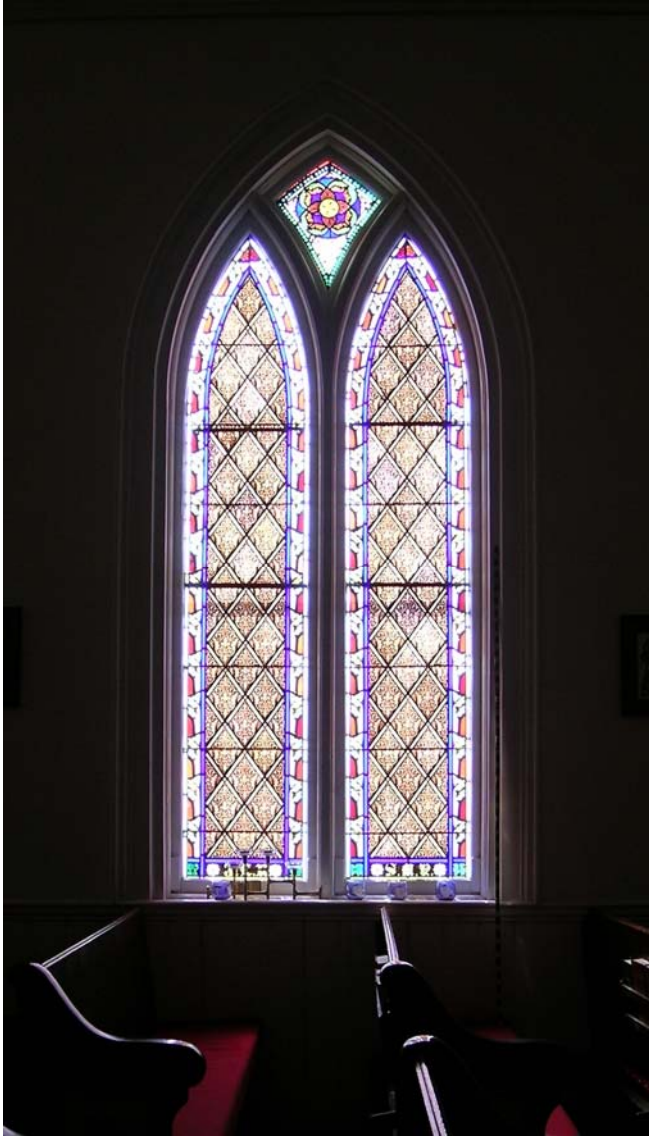
“But the most interesting feature of the whole structure is the windows of stained glass, set in with lead. On the sides there are eight windows in all, each donated by three persons together as follows: the windows are in two sections, and a centre piece above, each part being the donation of a single person. The centre piece in each window is a memorial to departed children of the church, whose initials are inscribed in German text at the expense of fond parents. The sections of the windows are likewise inscribed with the initials of the donors. We have no space for the names of donors, and doubt if it would be in order to give them. The memorial head pieces are lovely emblems—lillies, a rose, an angel child, a crown of glory, a dove, a bible, and a lamb.

9. Stained glass window in nave.

On each side wall are stained glass windows in molded lancet surrounds. The windows, each divided into two narrow sections by the center mullions, have a design of quarrels with fleurs-de-lis, crosshatching, and foliation painted in black on light brown. The

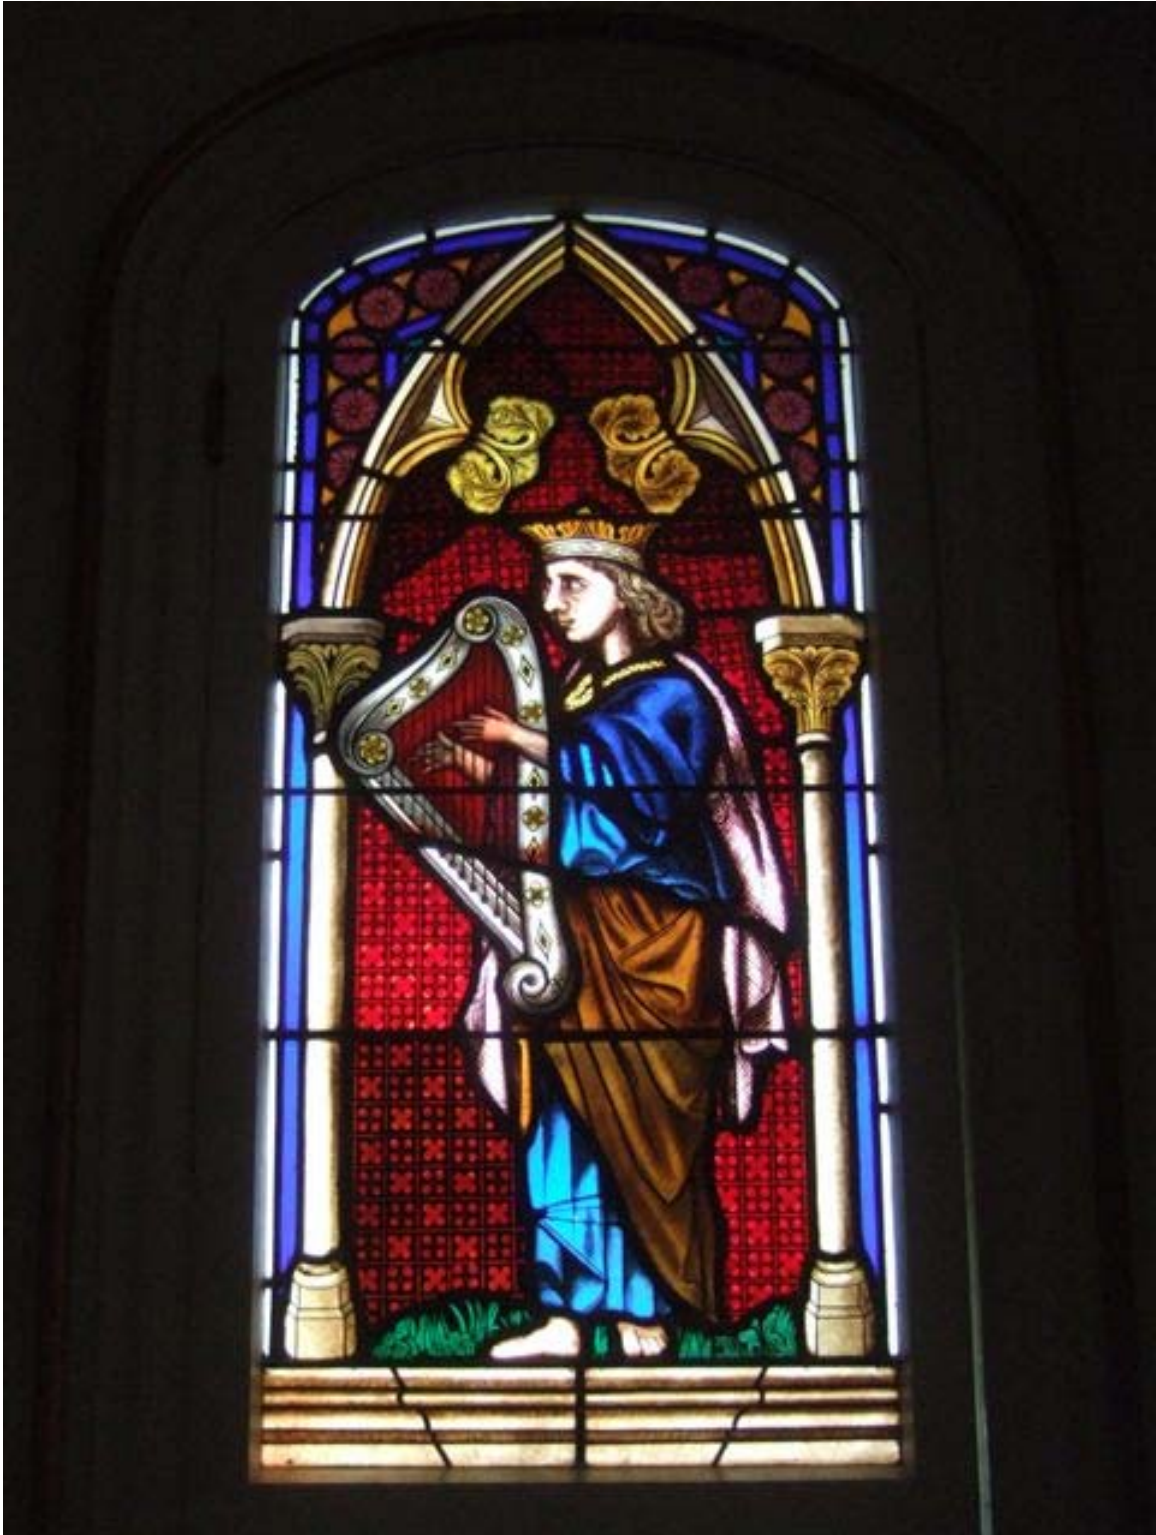
10. David window.

“There is a stained glass window in the door which opens from the gallery into the tower. The emblem is ‘David playing on the harp.’ It was donated by the mechanics that worked on the church. The light on this window comes through ground glass in the front window of the tower, which is about twelve feet distant [the separation is considerably less]. The other eight windows have stained glass trefoil quarry [quarrel] work with colored borders. The tops above the windows are kite form; in each there is an emblem, *in memoriam* of the little children that have gone from the earthly home to the heavenly land. The emblems are lilies, lamb, bible, dove, anchor, angel-child, rose and crown. All the windows were donated. The light through these windows is agreeable to the eye and gives a delightful effect to the place of worship.

The *Nevada Pulpit* account notes that the David window was backlit by a ground or translucent glass window. The date this window was replaced by the present stained glass window is unknown, although the window is in keeping with the character of the Pacific Glass Works windows, especially the chancel window with which it shares a similar geometry of diamonds, quatrefoils, and rosettes. Most of the windows, the tower window in particular, are reminiscent of a style of stained glass known as grisaille, defined in 1897 as glass that is chiefly "white or whitish, relieved only here and there by a line or a jewel of colour." In painting, the gray tone of grisaille is stressed ("grisaille" is derived from the French word for gray), which may explain the neutral brownish tint of the side windows. The David window, in contrast, is dominated by rich jewel tones.<sup>25</sup>

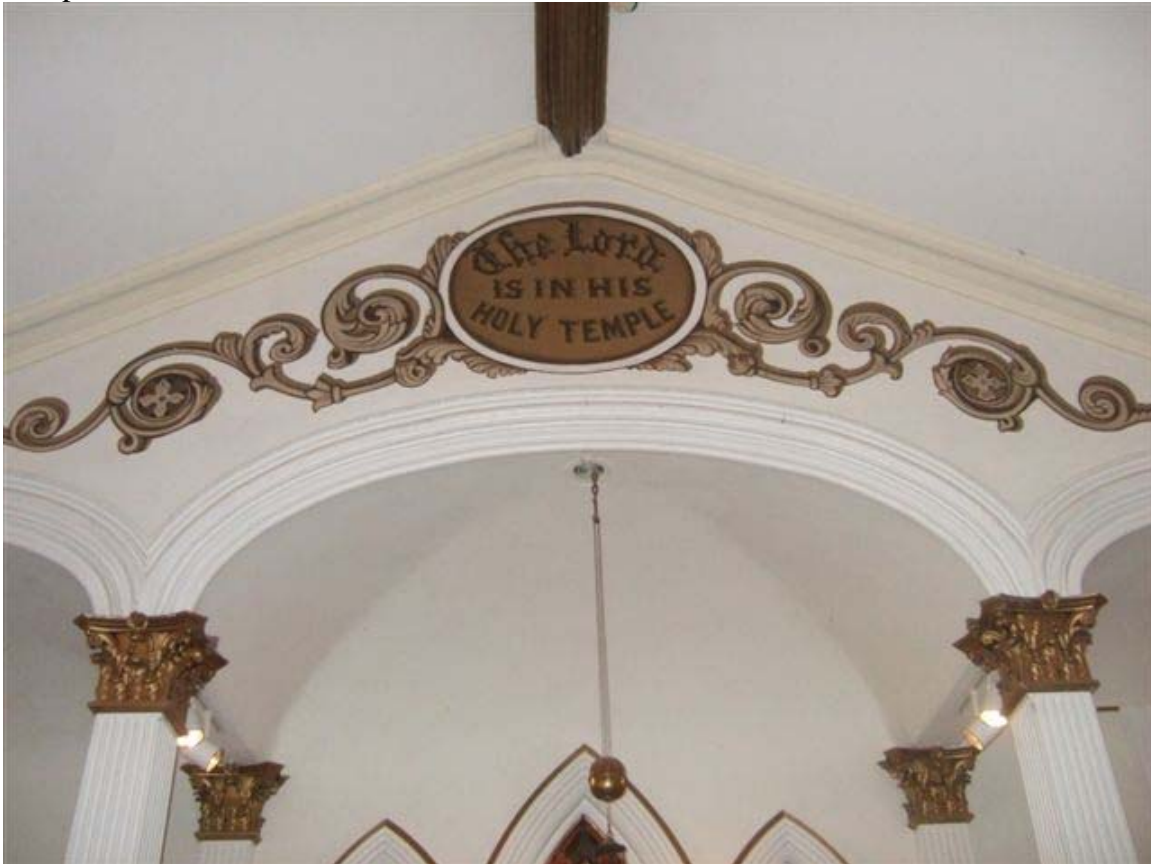
11. Grisaille painting over chancel.

The term “figured silk” is also confusing. The reference appears to be to the section of wall above the chancel arches, which in July 1874 Rev. Allen described as having the grisaille painting that still adorns the surface. Maybe the *Appeal* writer’s meaning was “adorned or ornamented with patterns or designs,” but this would not explain his failure to mention the “Holy Temple” inscription, the main feature of the painting. As a technical term, figured silk means silk fabric with repetitive floral or geometric patterns (“figures”). Wallpaper can also have such patterns. One of the wallpapers used in Saint Augustine’s Catholic Church in Austin, Nevada, in the nineteenth century (type 3), was printed with a light gray on darker gray pattern meant to evoke watered silk. Perhaps similar wallpaper was used initially above St. Peter’s chancel arches and then changed between early March and July 1874.<sup>21</sup>

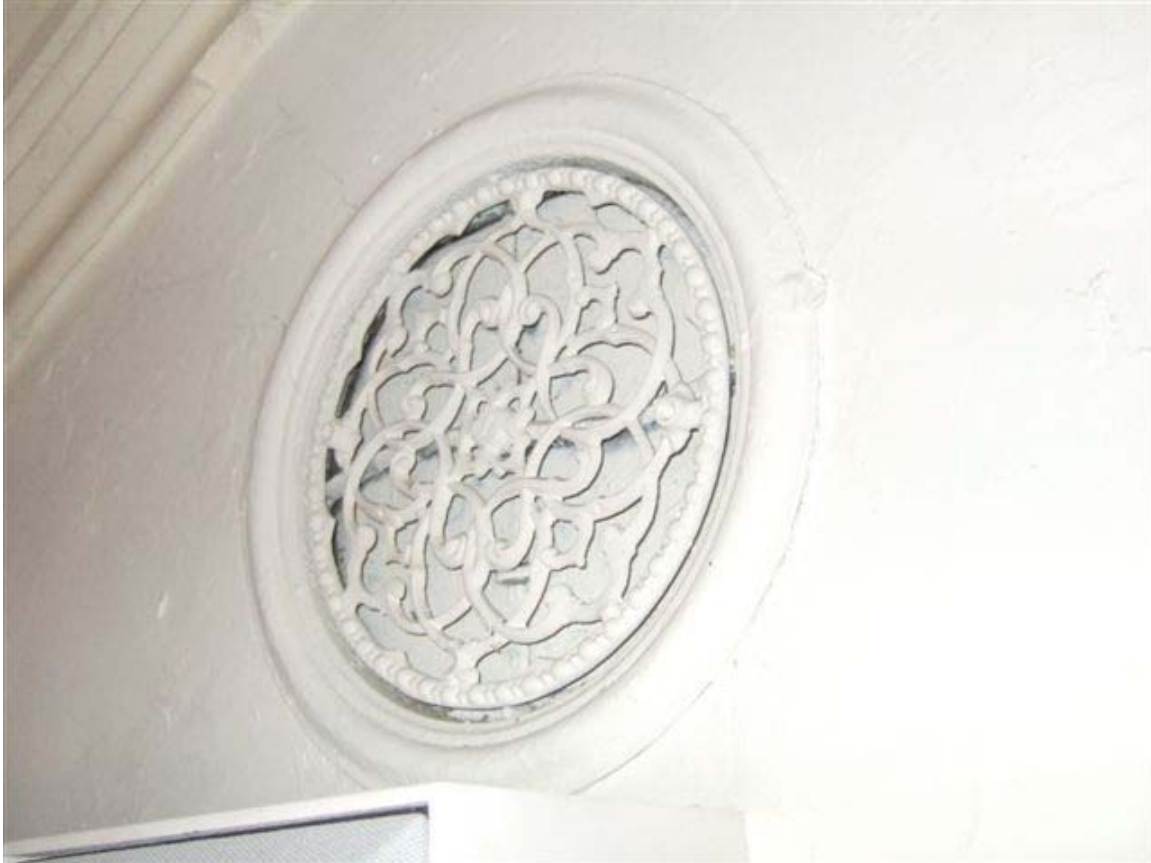
school-room are well ventilated having cold air registers in the floor and registers in the walls near the ceiling, and an open blind window in each end of the building.”<sup>6</sup>

13. Ventilator in gallery.

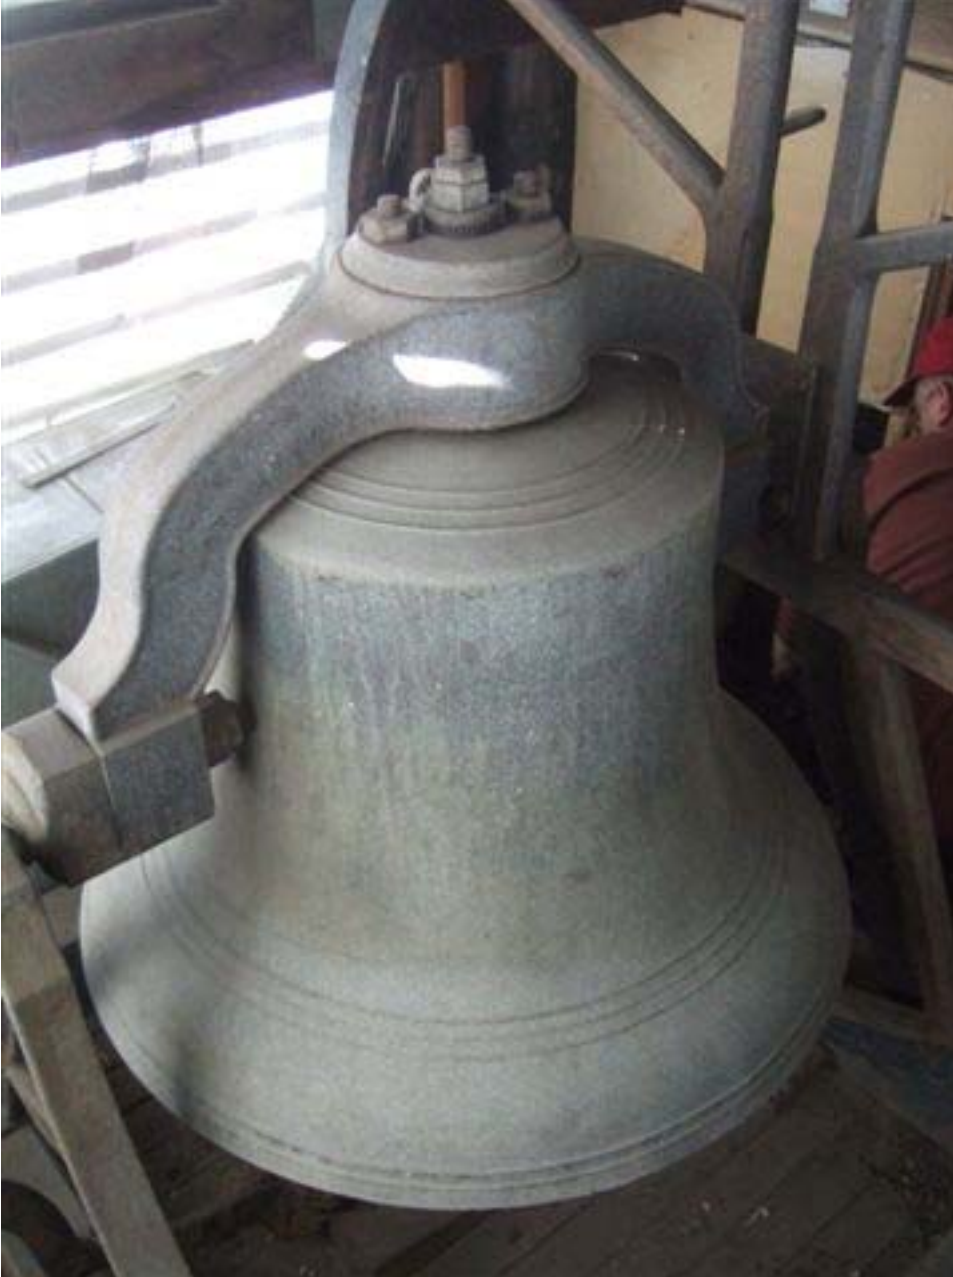
14. Bell in tower.

been painted only seven years before, the building was repainted by painter W. D. Cotterell. The exterior was painted again, in 1902, and the same or similar yellow drab color was used as in 1873-74 and, presumably, 1881. The interior was repainted with calcimine paint in 1904. St. Peter's bell cracked at some point and was unsuccessfully repaired several times before it was recast with a less brittle alloy by the Virginia and Truckee Railroad shops in 1881. Gas fixtures were installed in the church in 1895.<sup>8</sup>

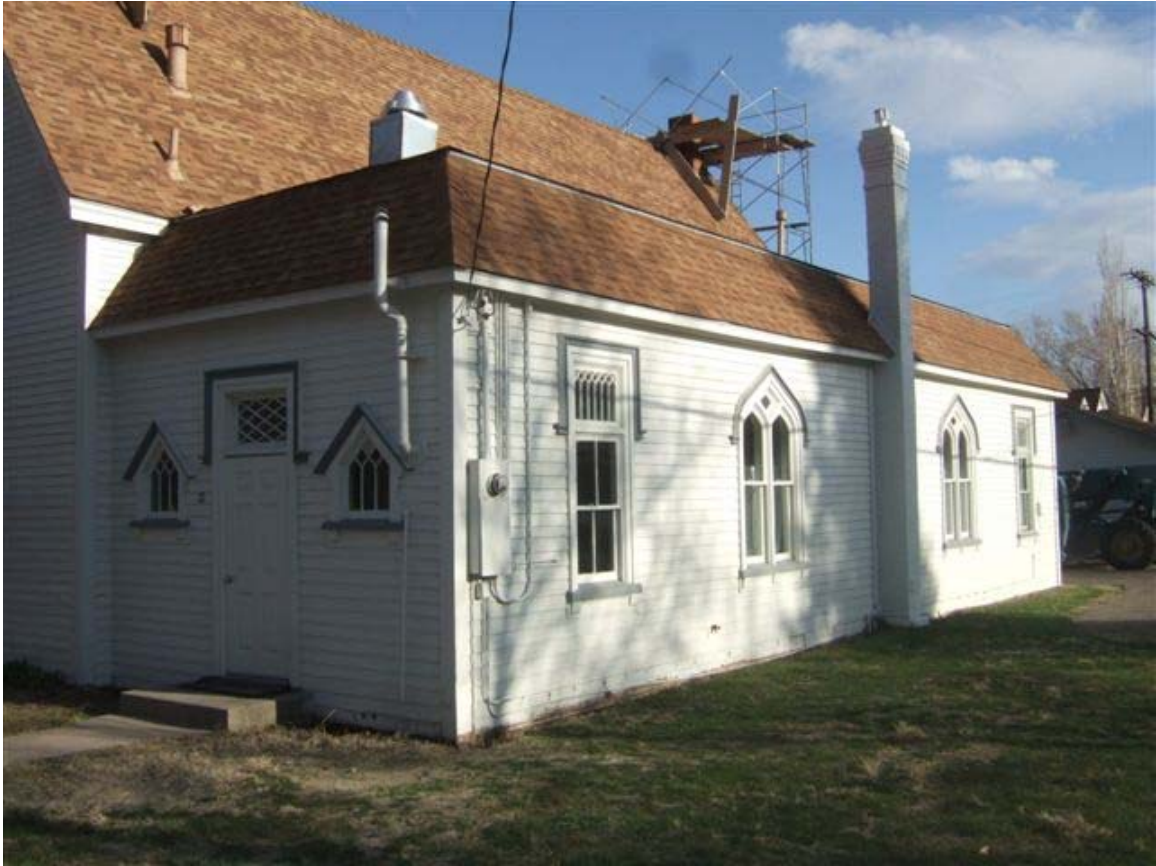
15. North and west sides of 1911 addition.

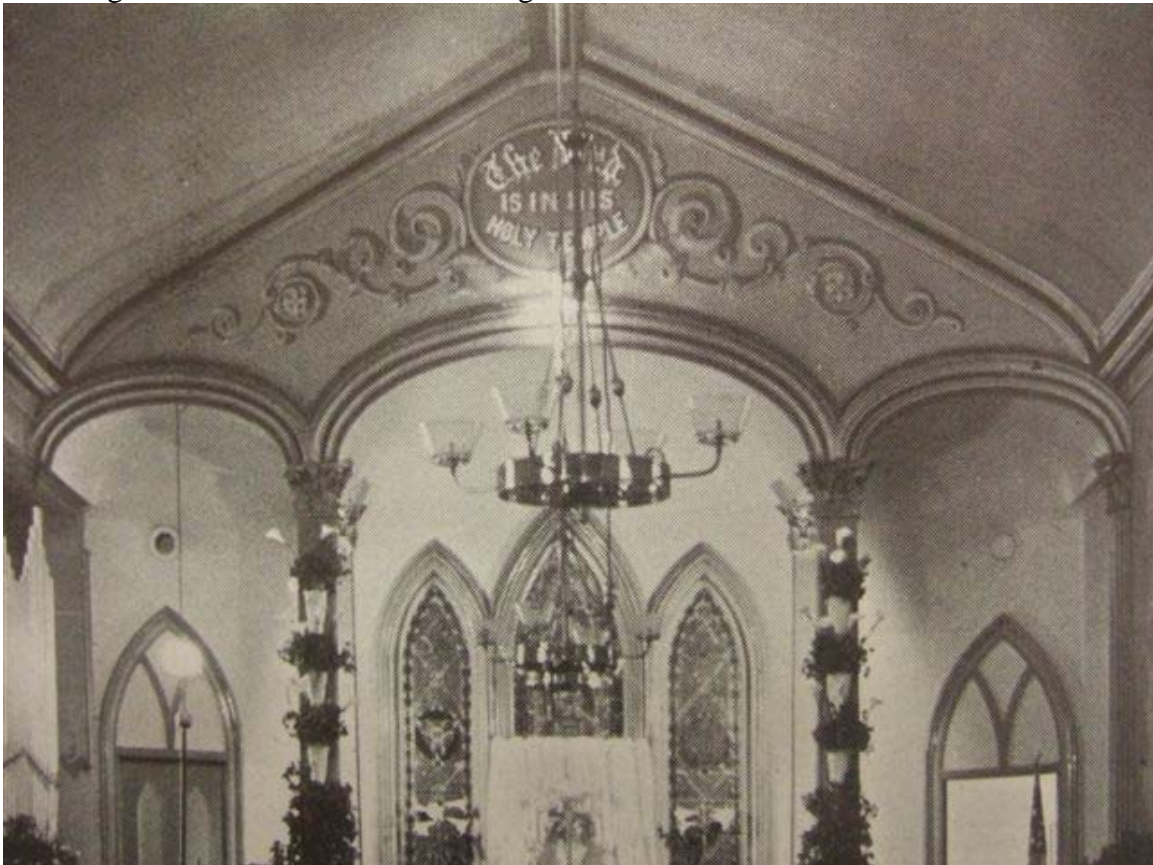
16. 1940 photo of the chancel.

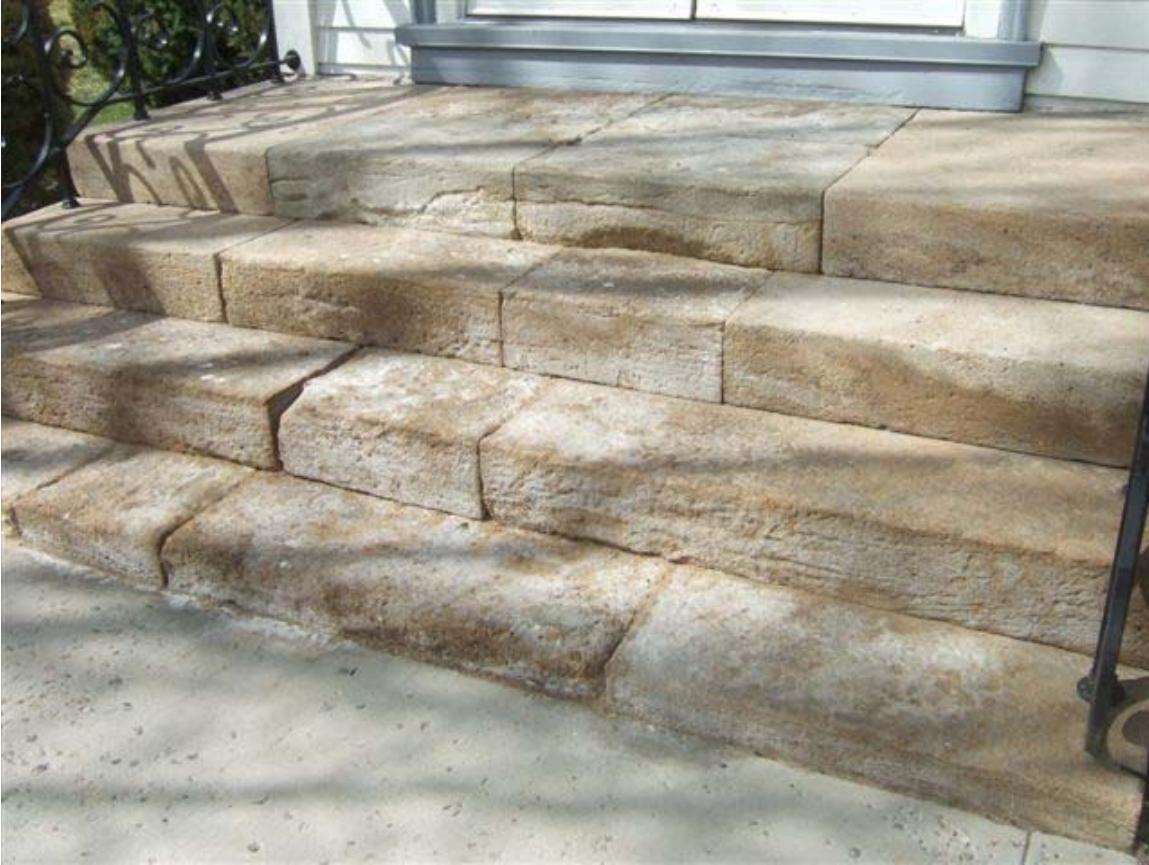
17. Front steps.

The foundation is constructed of ashlar sandstone blocks that were probably quarried at the Nevada State Prison Quarry. Most of the blocks have irregular surfaces that are described in the National Register nomination as “roughly pick-dressed,” or finished with a heavy pick or wedge-shaped hammer. The blocks at one front corner have smooth edges, otherwise the surface texture extends to the edges of the blocks. Blocks under later sections of the buildings are different in appearance. Sandstone was also used for the front steps, which were added in late 1899 or early 1900 and have ornamental metal railings that appear to date to the mid-twentieth century (before 1963). The building has several masonry stove flues. Above the ridge at the ends of the 1873-74 transverse wing rise interior brick flues that have corbelled caps with alternating projecting and recessed header bricks. (The above-roof sections of these flues were partly taken down and reset in the same form in March 2008.) On the west elevation is a brick flue with a corbelled cap similar in form to those of the 1873-74 flues, as well as a concrete base and a small iron ash trap door. This flue appears to occupy the location of an 1873-74 flue but it appears to have been reconstructed, presumably in 1911 when other changes were made to the rear of the church. A cinder block flue for a modern furnace rises on the front elevation to the right of the steeple.

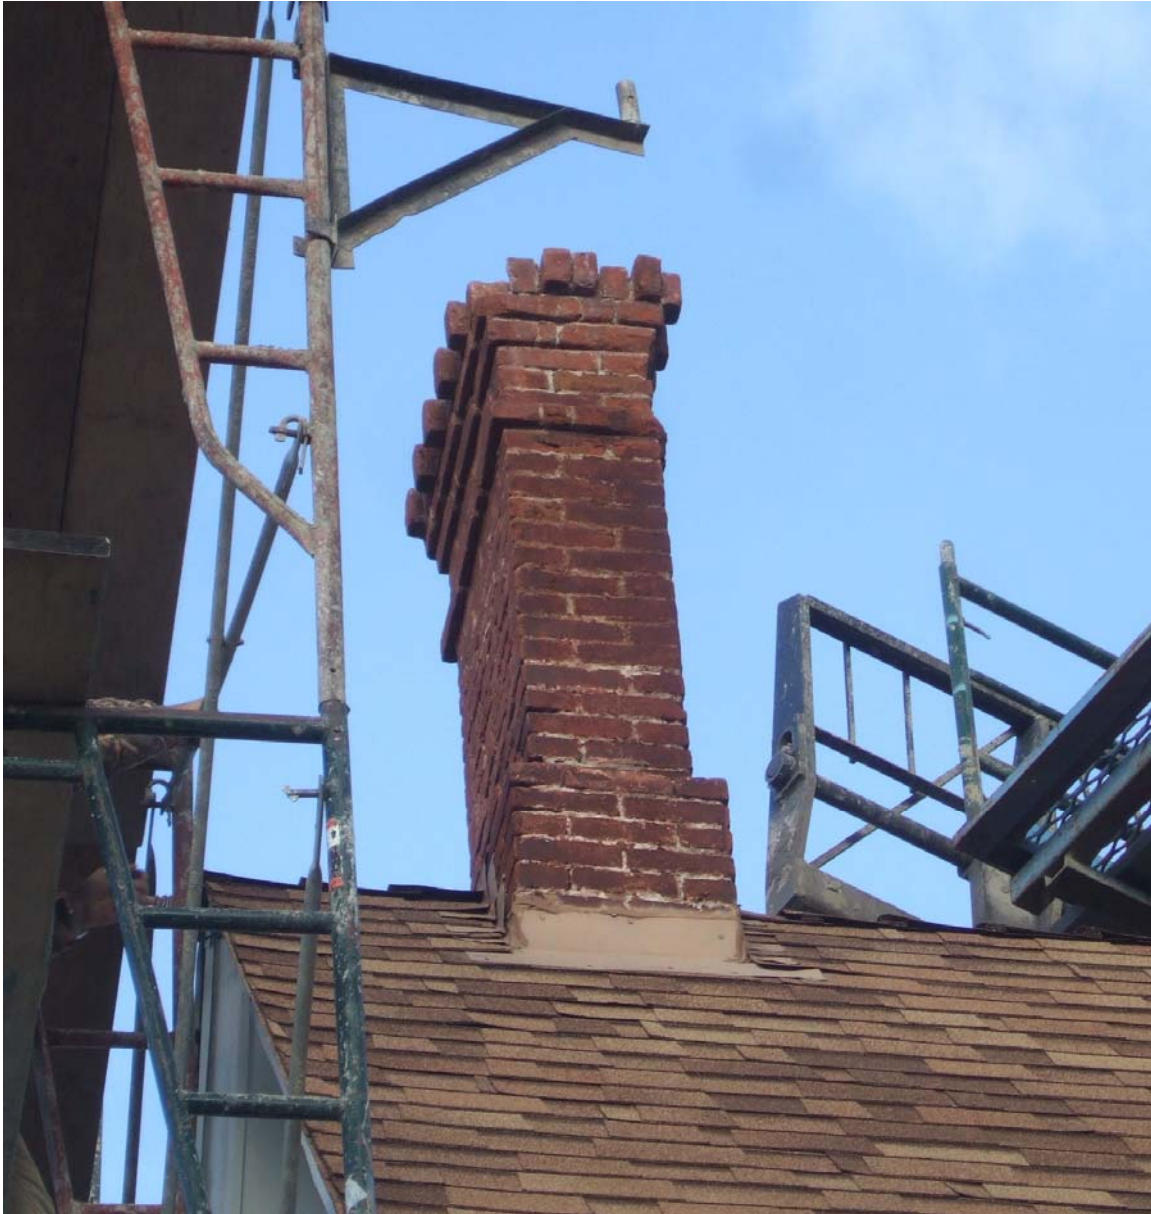
18. One of the 1873-74 flues under repair in March 2008.

The exterior of the church is in excellent condition. The wood siding and trim are in good repair. The stone foundation is solid, although there are a few areas where the stones have slight delamination. The windows on the Parish Hall are protected by exterior storm windows and are in excellent shape. The remaining windows should have the same treatment. The front entry steps are in need of repair. The crawl space is well vented. The steeple was repaired after fire damage and is in good condition. At the west and northwest edge of the building, the grade was above the level of the wood clapboards. This earth was removed and replaced with gravel in the spring of 2008. Drain tile needs to be added in this area and run to daylight at the east edge of the site. The chimneys were recently rebuilt. The roof is relatively new and in good shape.

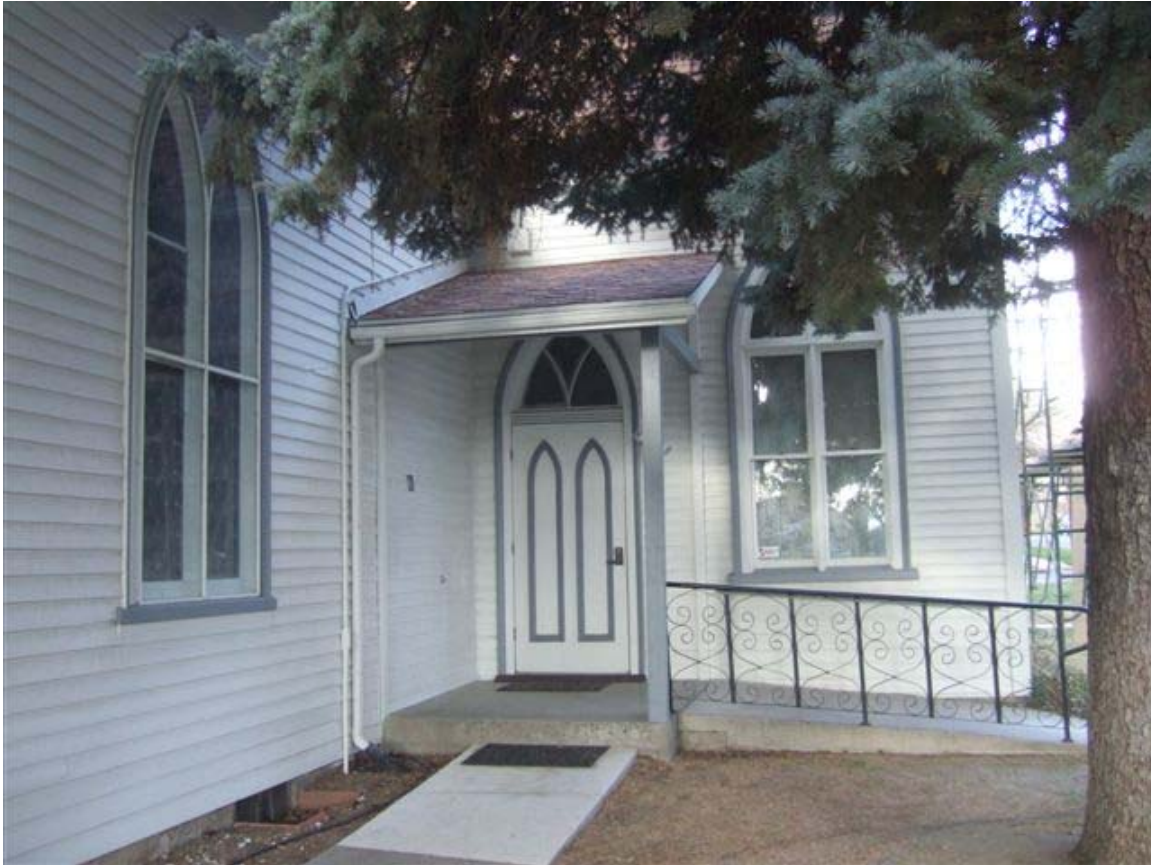
19. North entry to parish hall.

In addition to the entries mentioned above are several others. The north entry of the 1873-74 wing has two molded lancet panels and a lancet transom. (A matching entry and transom at the south end of the wing, now interior, is described below.) It is sheltered by a shed-roofed porch with a simple wood post and beams that replaces an 1873-74 entry porch. The porch floor is concrete and connects to a short concrete ramp with a decorative metal railing that in turn connects to the sidewalk along Telegraph Street. (In the weatherboards at this porch is a seam that represents the division between the 1867-68 and 1873-74 sections of the building.) The entry at the south end of the 1911 addition is accompanied by modern features such as a small gabled roof on struts and a wooden wind guard.
