## Saint Peter's Episcopal Church Report

June 30, 2008

## Report Summary

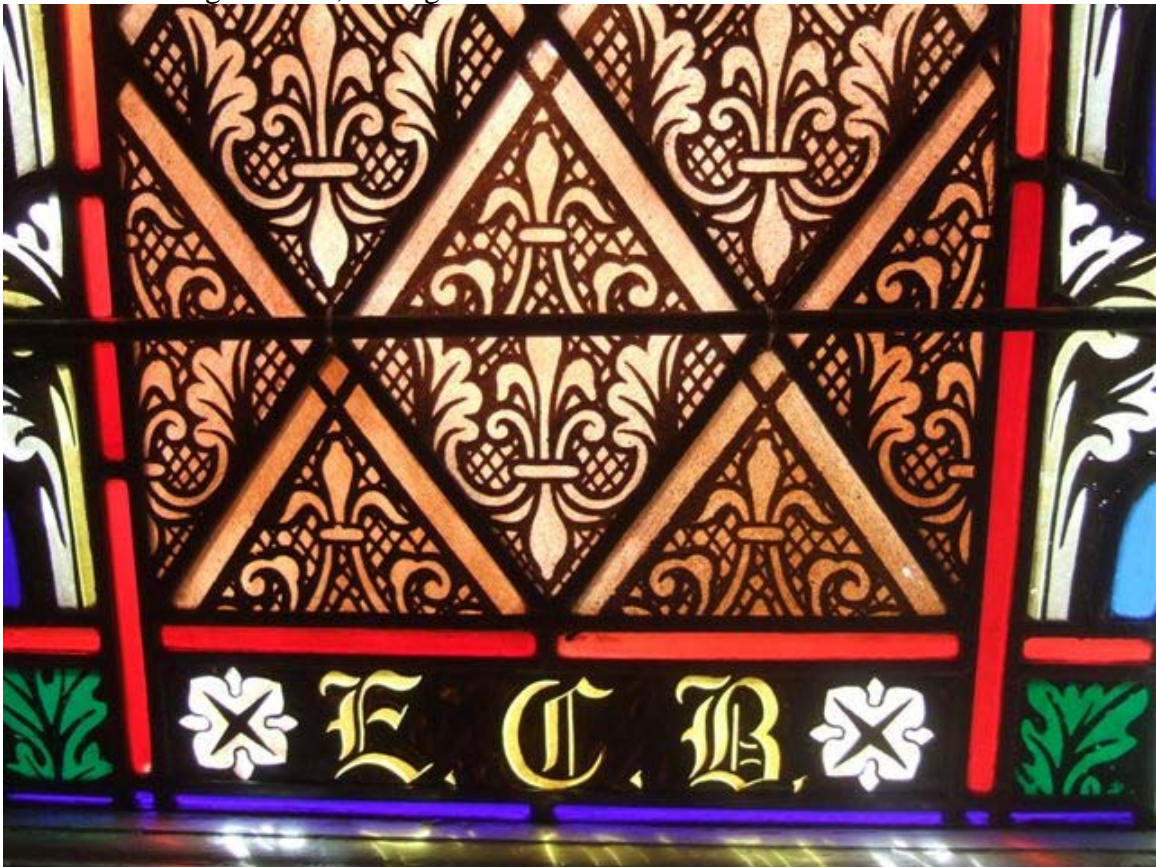
On each side wall are stained glass windows in molded lancet surrounds. The windows, each divided into two narrow sections by the center mullions, have a design of quarrels with fleurs-de-lis, crosshatching, and foliation painted in black on light brown. The

borders are blue and red with foliation in white and yellow. At the bottom of each section are initials, presumably of the individuals who donated with windows, and in the diamond-shaped light at the peak of each window are the following emblems: anchor, angel, cherub, and rose on the south side; crown, lily, lamb, Bible, and dove on the north side. Below the windows is a vertical beaded board wainscot with a molded chair rail. The pews have shaped ends with turned buttons in the armrest curls and rectangular panels to some of which have been affixed wooden numerals. The pews were grained in 1874 in imitation of koa wood (Hawaiian mahogany), and the present grained finish appears to be the 1870s painting. The panels are painted in imitation of blond wood and the surrounding woodwork is grained dark brown. Name plates were once attached to the pews but were removed in 1913. Near the vestibule doors stands a baptismal font of octagonal form carved from light gray stone. A bronze plaque mounted on the font notes that it was given to the Parish of St. Peter by Christ Church, Indianapolis, in memory of the Reverend Joseph Cruickshank Talbot. (The font was dedicated in 1935.) In places where the paint is chipped on the wall plaster is evidence of earlier paint or wallpaper in two shades of light brown, one lighter than the other.

21. Nave window detail.

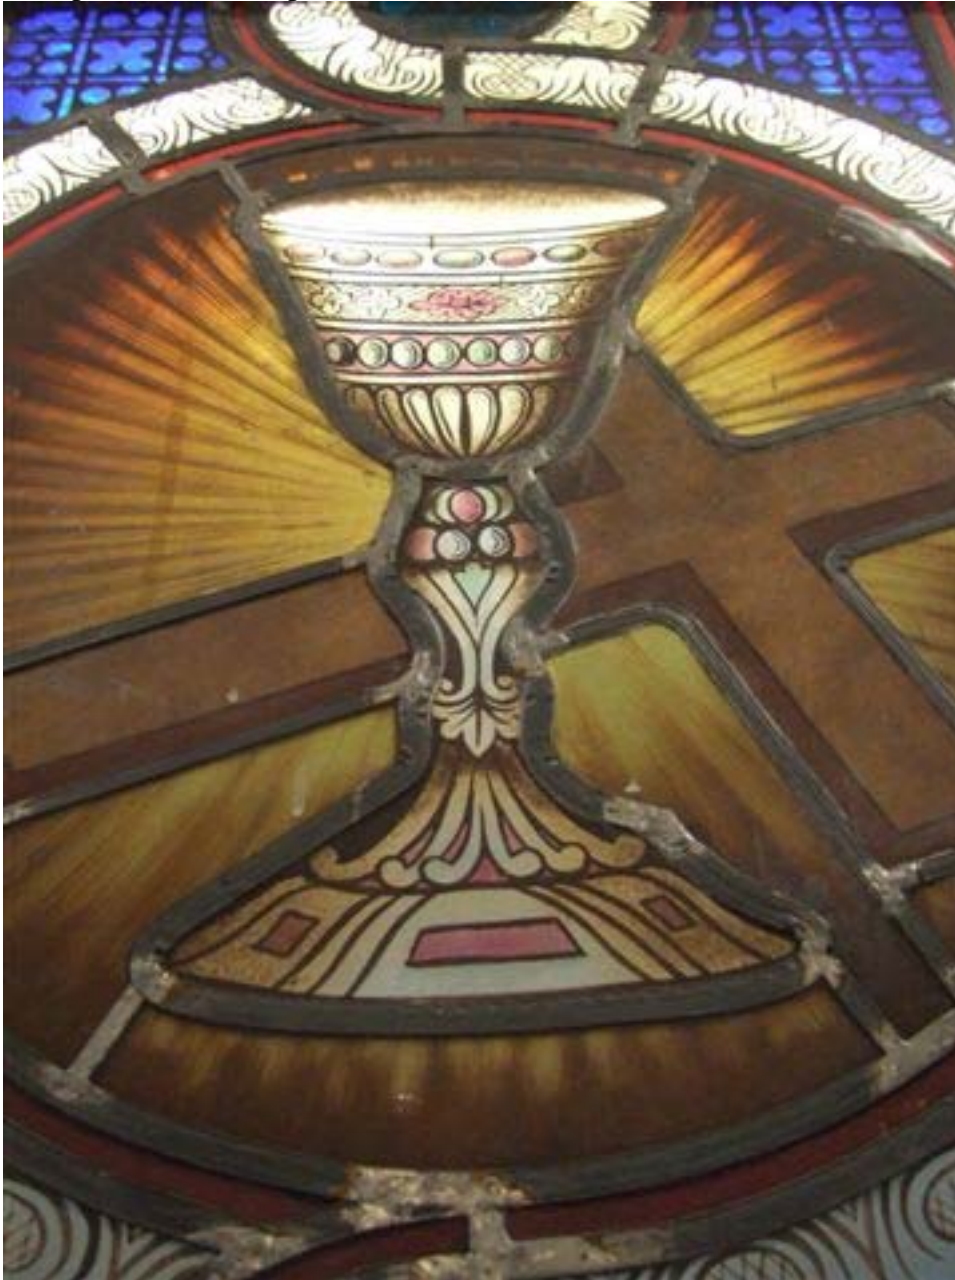
22. Sacristy window detail.

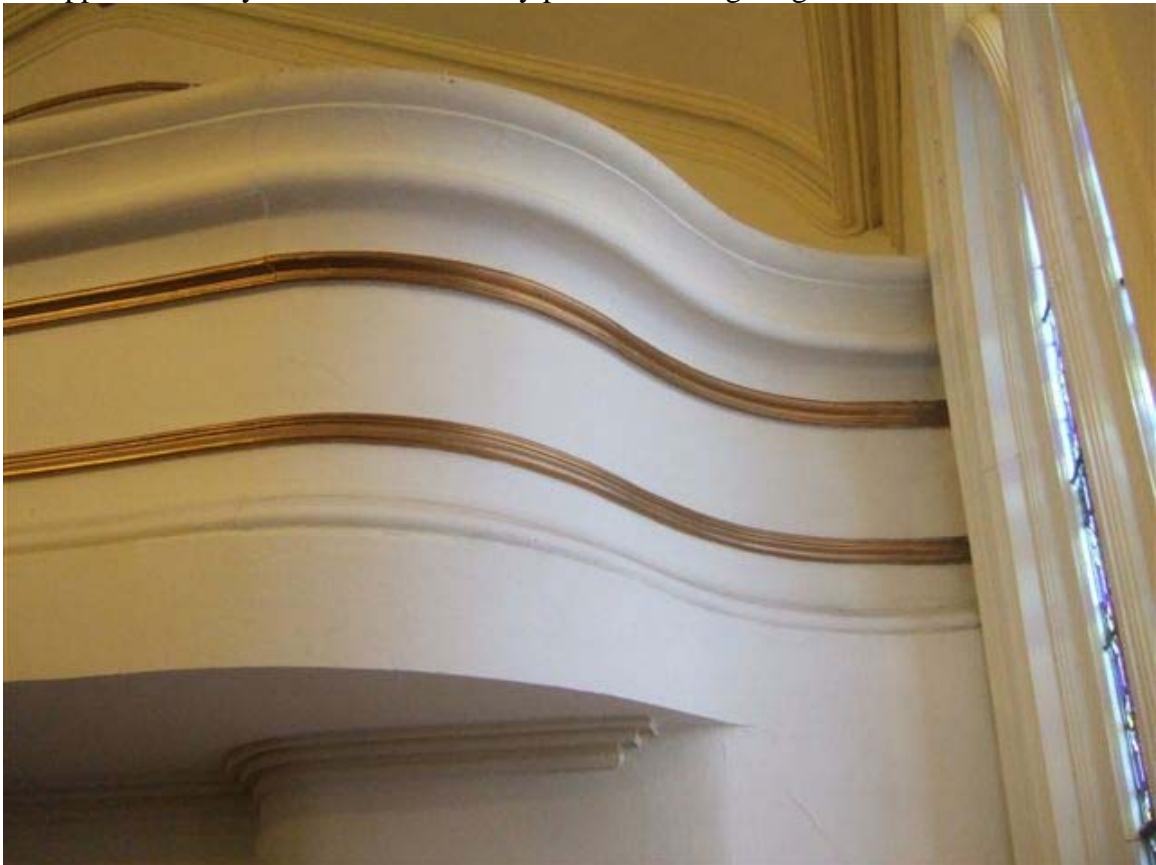
23. Gallery railing detail.

The gallery has a curved solid railing with a heavy molded lip and two moldings below that are painted gold. The inside surface of the railing is sheathed with vertical beaded boards. Over the stair, level with the gallery floor, is a ghost impression that may indicate an alteration to the stair or the gallery floor. Above, mounted on the wall, is a small shield-shaped wooden plaque of unknown (former) function. At the back of the gallery is a half-domed alcove that was presumably constructed to contain an organ. A doorway in a molded elliptical-arch surround leads from the alcove into the steeple. The door has modern louvered panels at its base, richly ornamented cast-metal door knobs, and an elliptical-arch stained glass window that portrays King David playing a harp. David is

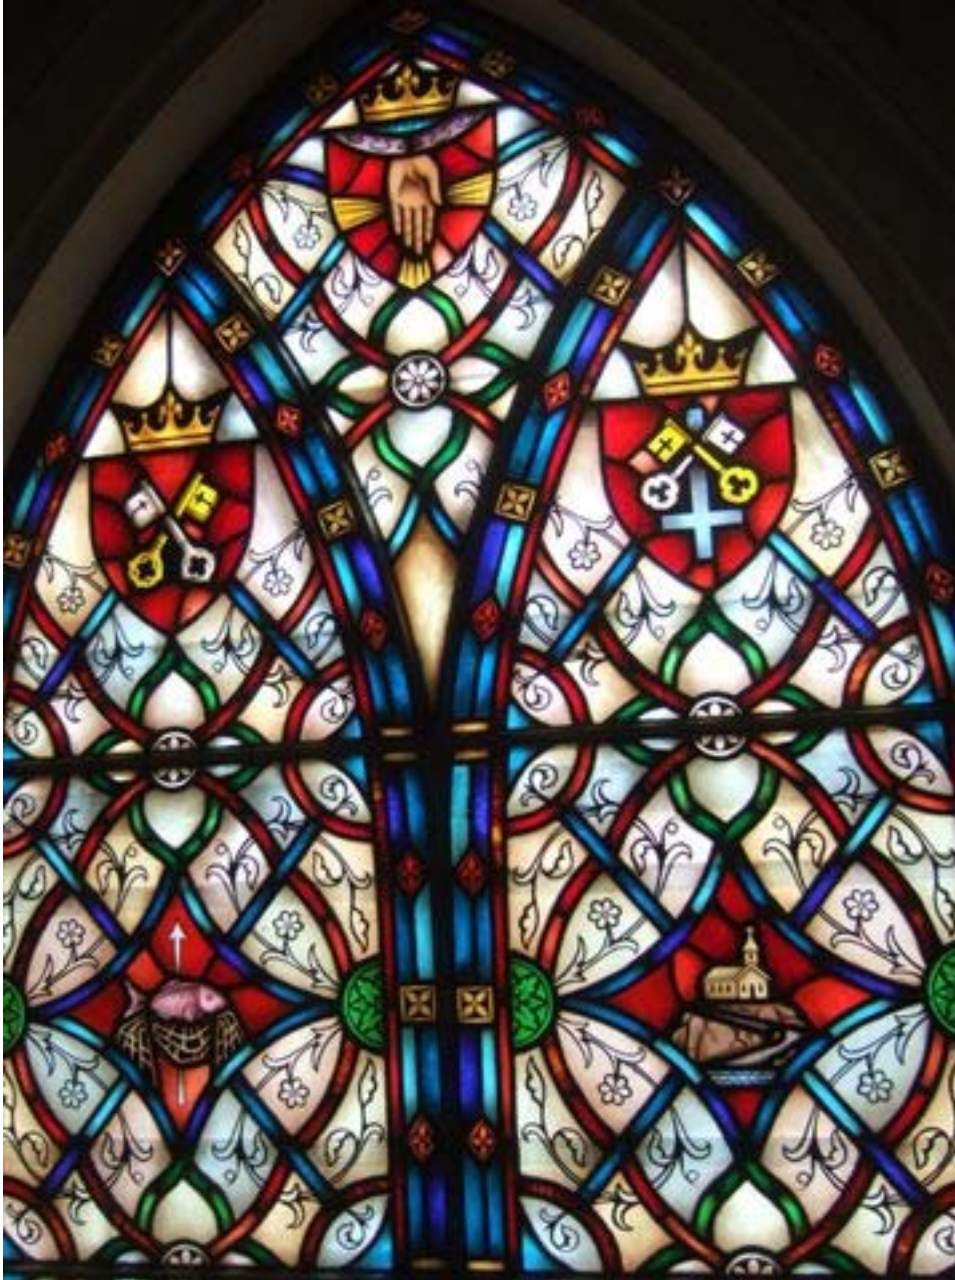
24. Tower window.

The predominately white coloration of the tower window is well suited to its function of transmitting back light to the David window. The original ground glass window provided similar light, so its replacement with the fancier stained glass window suggests the latter was meant to be appreciated from the outside. Perhaps it was lit by a lamp from within, just as the chancel window may have been backlit to make it more visible. There may also be a functional rationale for the brown tint of the side windows, which may have served to mute the glare of the Nevada sun. These speculations, combined with the aesthetic sophistication of St. Peter's windows, suggest considerable thoughtfulness on the part of the individual or individuals who planned the work. The Reverend George B. Allen appears to have played an important role. His precise description of the Trinity motif in the chancel window and its usefulness in teaching doctrine suggests he stipulated the window's design or at least selected it from options, perhaps in the form of a catalogue, provided by Pacific Glass Works. The David window is known to have been donated by John Parker and the other carpenters and craftsmen, which may explain its different character, although the similarity of its background pattern to patterns in other of the church's windows suggests it too was made by Pacific Glass Works.

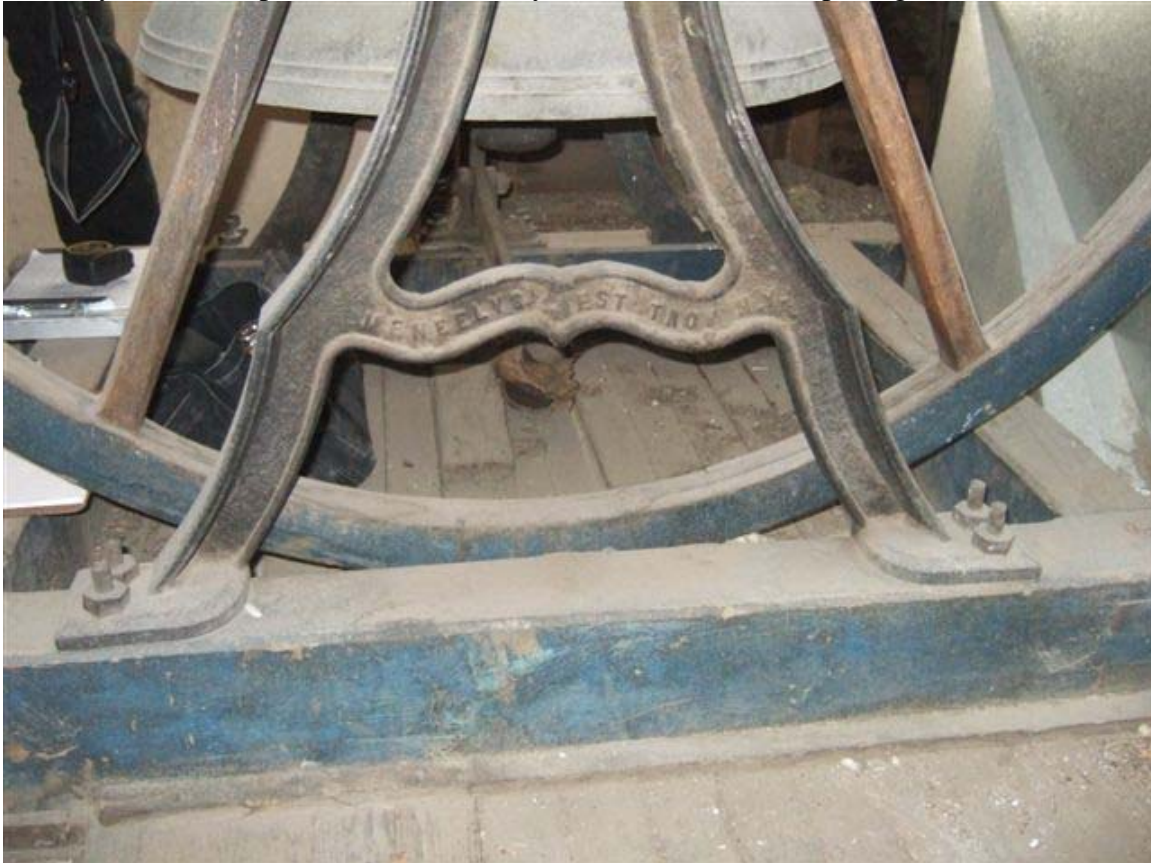
In the belfry are visible the heavy circular-sawn beams of which the steeple is constructed, many with scorching from the 1976 fire, as well as steel angle reinforcement and wooden members added in the 1977 reconstruction. The bell is supported by a wood and cast-iron yoke with a spoked wooden wheel that is used to swing the bell for ringing. Cast inscriptions on the decorative iron supports read McNeely's Rotary Yoke, Patented October 9<sup>th</sup> 1860, and McNeely's West Troy N.Y. The top of the bell has the cast inscription "Patd. July 28<sup>th</sup> 186[0 or 9]." The rim of the wheel and the wood base of the yoke are painted blue whereas the spokes and cross member of the wheel are natural wood. Stenciled on the wheel cross member is the word "fast" and other illegible words. One pull rope loops around part of the wheel whereas the second pull rope is attached to

25. Bell support.

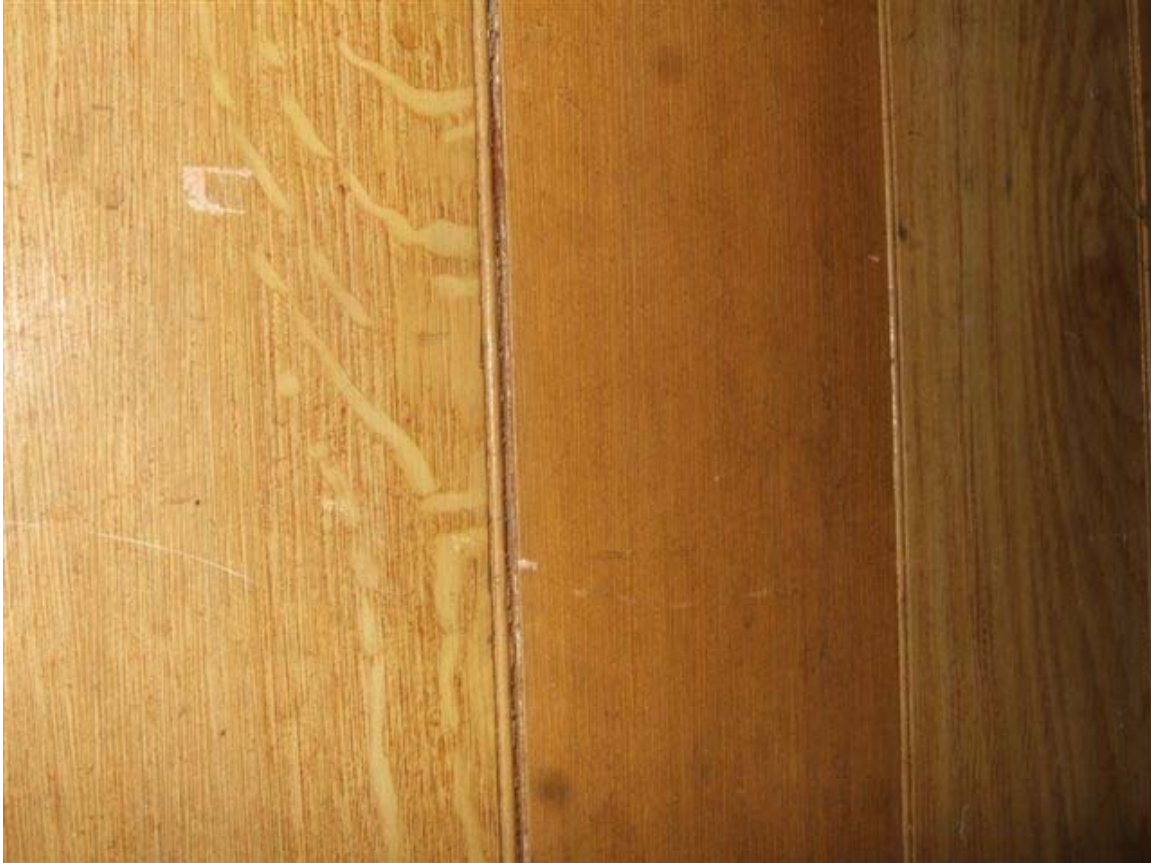
26. Preserved parish hall wainscot graining.

twentieth century. A partition was added above that creates the pastor's office and doors were inserted in the stage apron to create spaces for collapsable tables to be stored. Visible inside these spaces is the original grained finish of the wainscot. The graining subtly alternates from light to dark on alternating boards; the light boards to simulate oak grain whereas the darker honey-colored boards probably simulate maple. On one board is graffiti in pencil reading Clyde Heidinger, Dutch Berning, Prof Brown, and Fran Riley. At the east end of the stage/partition, between it and a formerly exterior door, is a lancet cast-metal panel with two slots, one long (about two feet in length) and the other short (less than a foot). The function of this feature is unknown, although its location next to an entry that formerly faced Division Street suggests it may have been a mail slot.

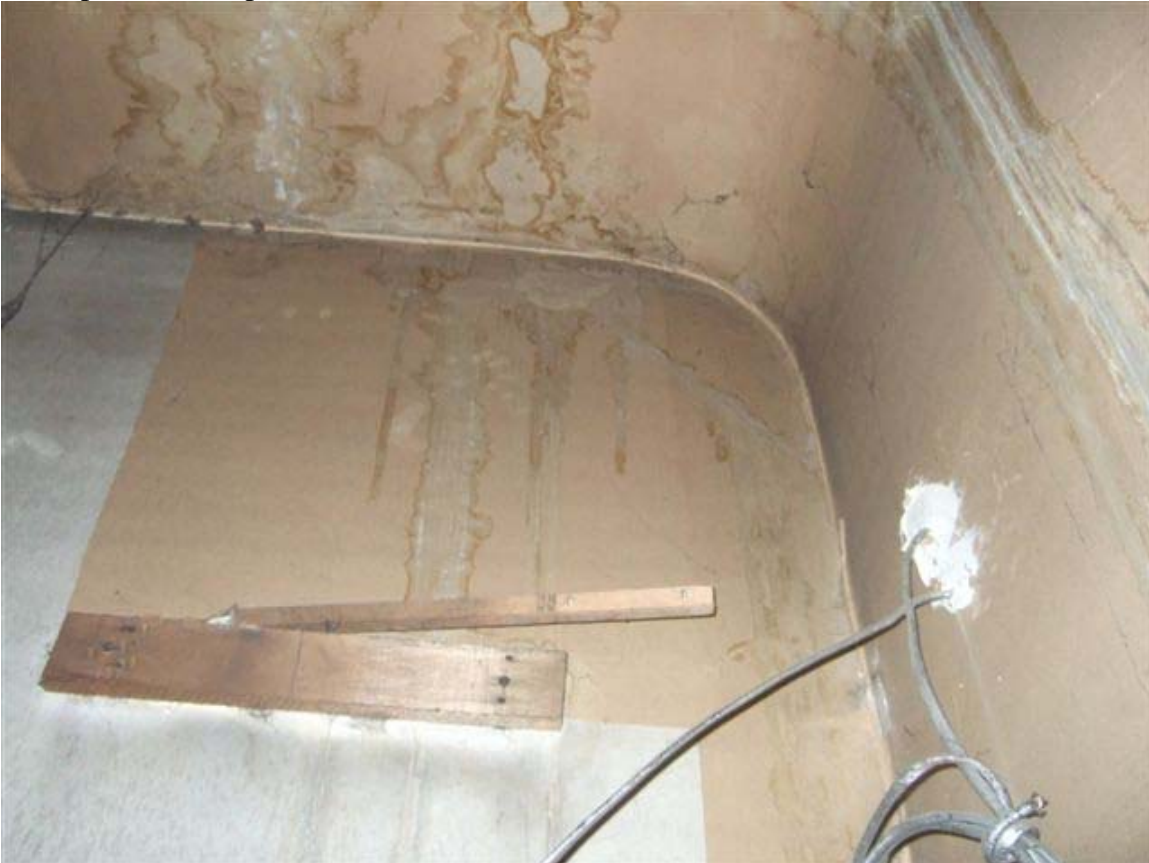
window to the exterior. Above the sacristy's drop ceiling are earlier finishes related to the former function of the space as an organ alcove. Historic yellow drab, light brown, and cream paint colors are preserved on the door transom trim (see architectural analysis for extended discussion). The room has rounded wall-ceiling junctures (a projection of the frame visible in the chancel) and surfaces have two colors: earlier light gray paint or soot-darkened white paint or plaster, and later (possibly 1920s) light brown wallpaper. The areas where the gray color is visible may represent the location of some former fixture, perhaps associated with the organ case. A similar light brown color is visible under later white paint in the space above the restrooms.

27. Organ alcove ceiling preserved above the sacristy ceiling.

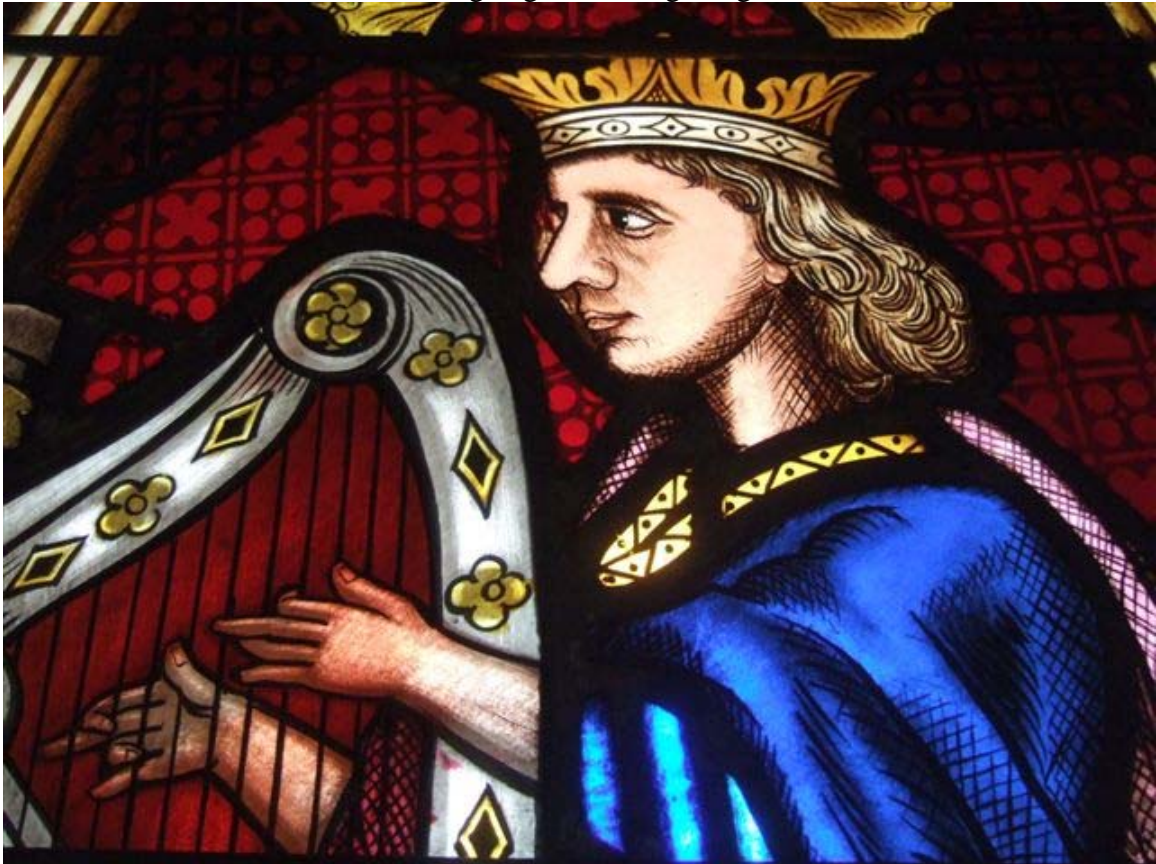
28. Detail of the David window, which was given to St. Peter's by the 1873-74 workmen.

glass was produced during the first few years of John Mallon's specialization in the craft. Mallon and his workers at Pacific Glass Works had clearly mastered the technical challenges of making stained glass by 1873—the glass appears bright and sound—although the relative crudeness of the rendering of David's face shows artistic limitations.<sup>23</sup>

The *Nevada Pulpit* account notes that the David window was backlit by a ground or translucent glass window. The date this window was replaced by the present stained glass window is unknown, although the window is in keeping with the character of the Pacific Glass Works windows, especially the chancel window with which it shares a similar geometry of diamonds, quatrefoils, and rosettes. Most of the windows, the tower window in particular, are reminiscent of a style of stained glass known as grisaille, defined in 1897 as glass that is chiefly "white or whitish, relieved only here and there by a line or a jewel of colour." In painting, the gray tone of grisaille is stressed ("grisaille" is derived from the French word for gray), which may explain the neutral brownish tint of the side windows. The David window, in contrast, is dominated by rich jewel tones.<sup>25</sup>

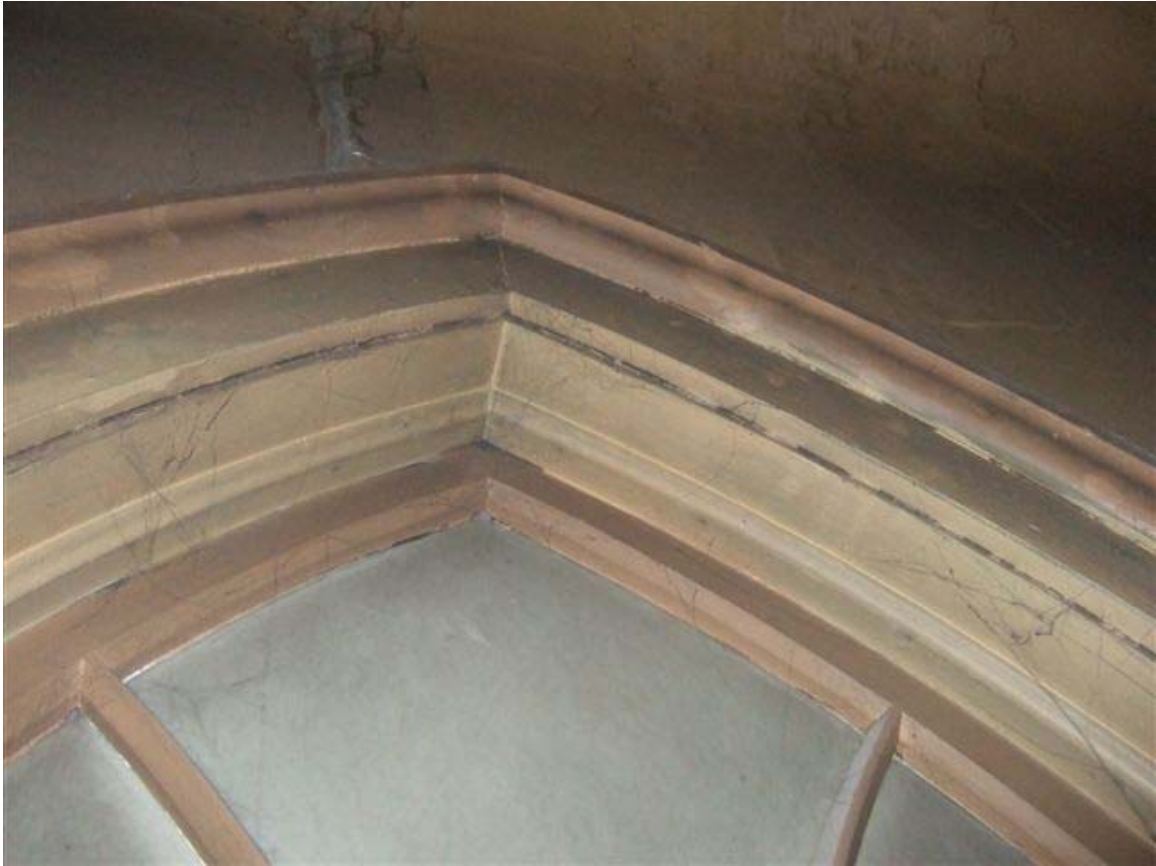
29. The sacristy transom appears to preserve 1881 exterior paint colors.

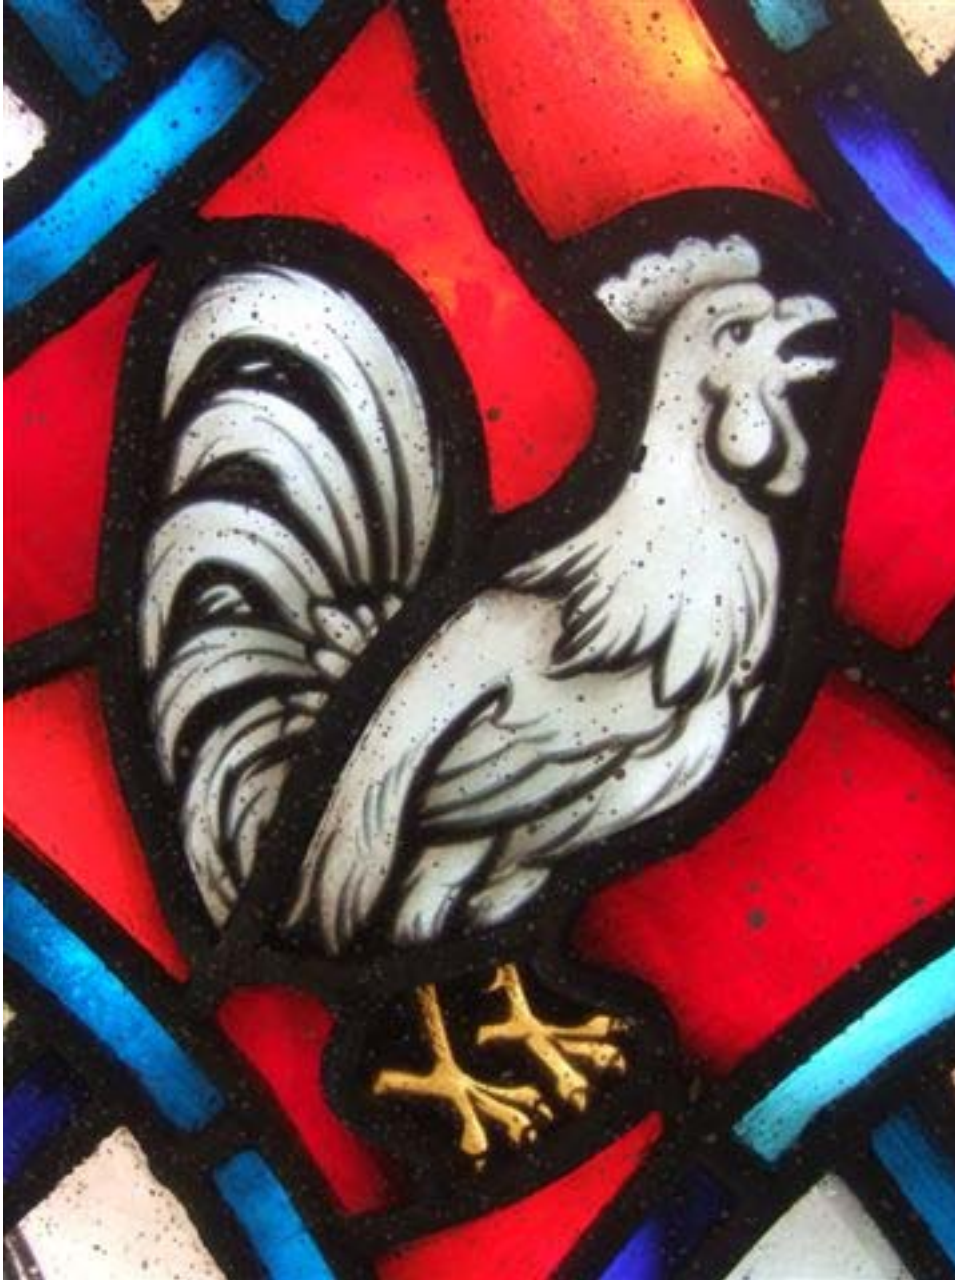
30. Rooster emblem in the tower window.

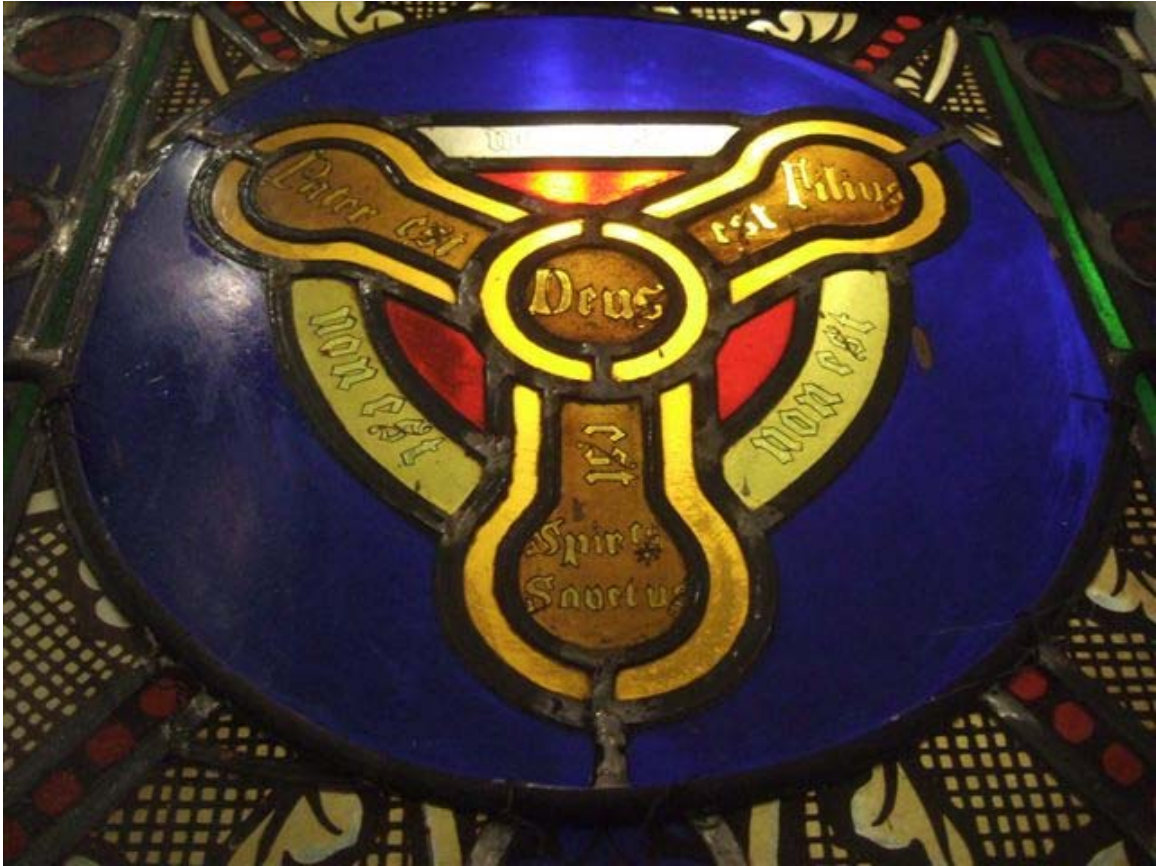
31. The Trinity emblem in the chancel window.
